Tornadoes and Straight-Line Winds

February 27th-28th, 2011

Overview

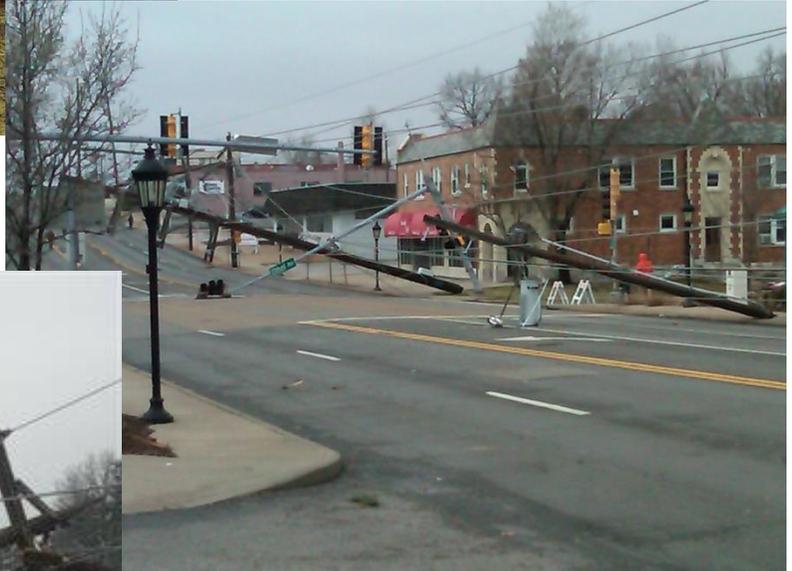
Power line damage in Hazelwood along Fee Fee Road south of McDonnell Douglas Blvd.

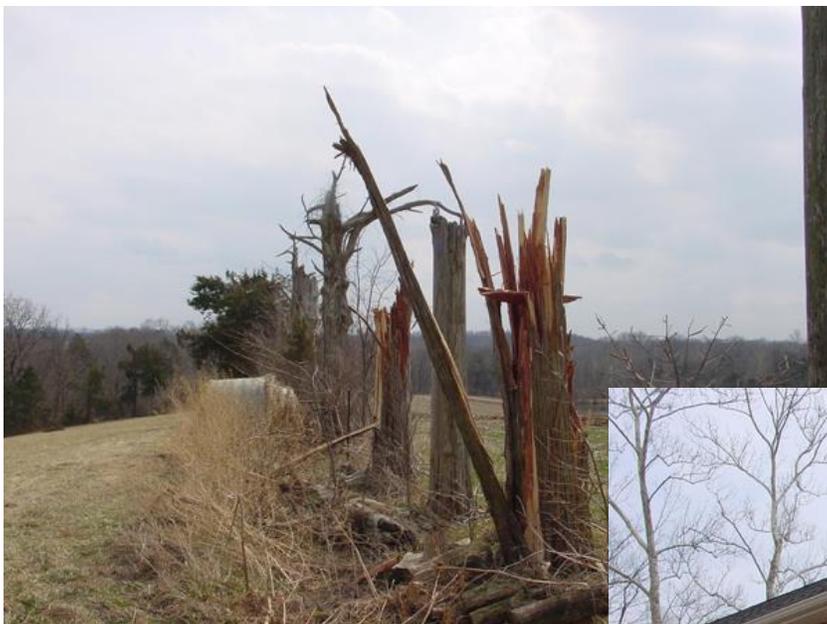
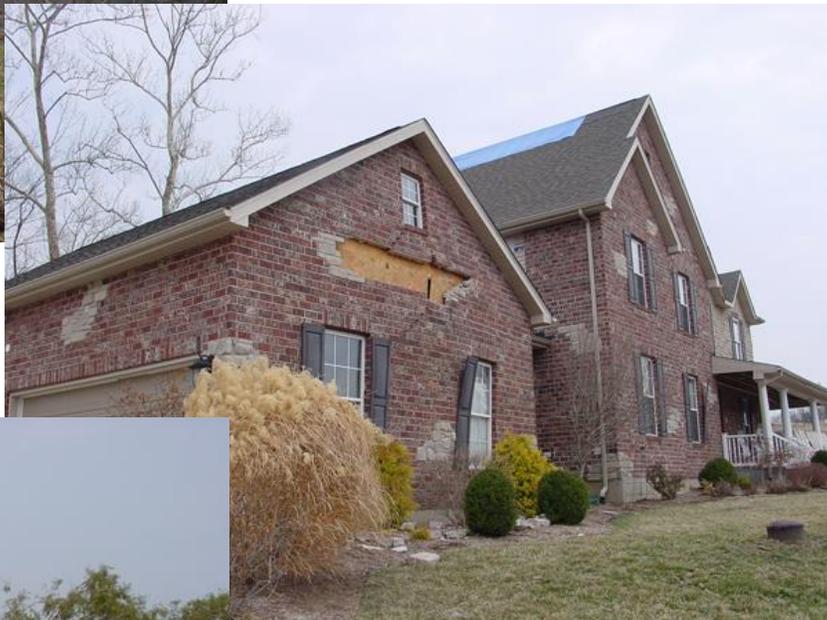
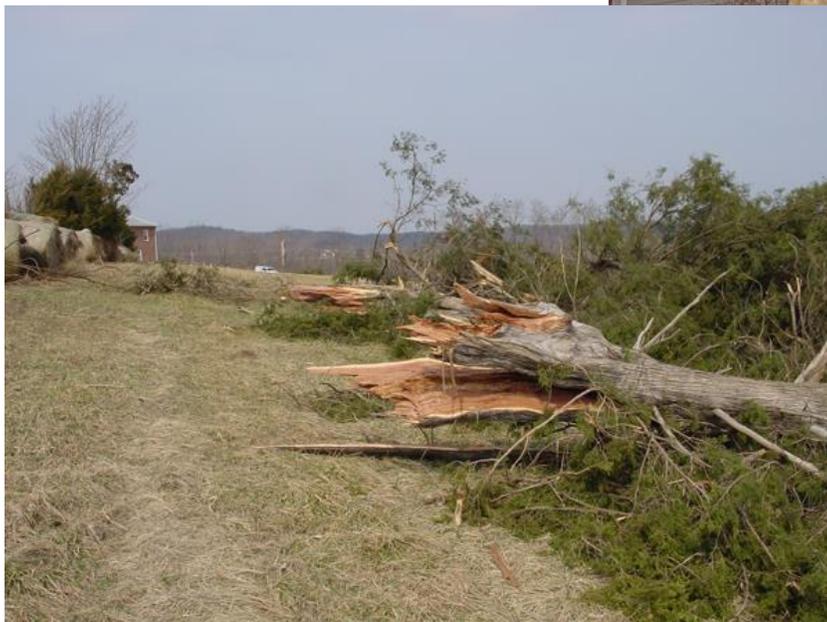
The tornado touched down near the Balducci Winery, about 3 miles west-northwest of Augusta. The tornado then continued to the east, producing intermittent damage along Highway 94 before moving into the Missouri River Valley about 4 miles southwest of Defiance. The tornado crossed the Missouri River and eventually lifted just east of St. Albans in extreme northeast Franklin County. The total path length was 9.4 miles, with a width that ranged from 50 to 200 yards. Maximum damaged, noted at several locations along the path, was estimated at EF1. Some of the more significant damage included the total removal of a roof from a century old home at the Balducci Winery, significant tree and home damage 1 to 2 miles east of the winery, large trees snapped at a Catholic Church 1 mile northwest of Augusta, and structural damage to a home just northeast of Klondike Park.

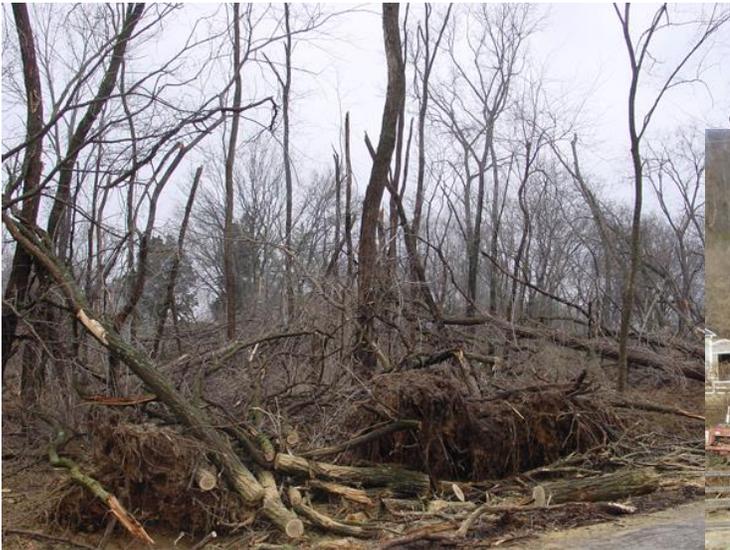
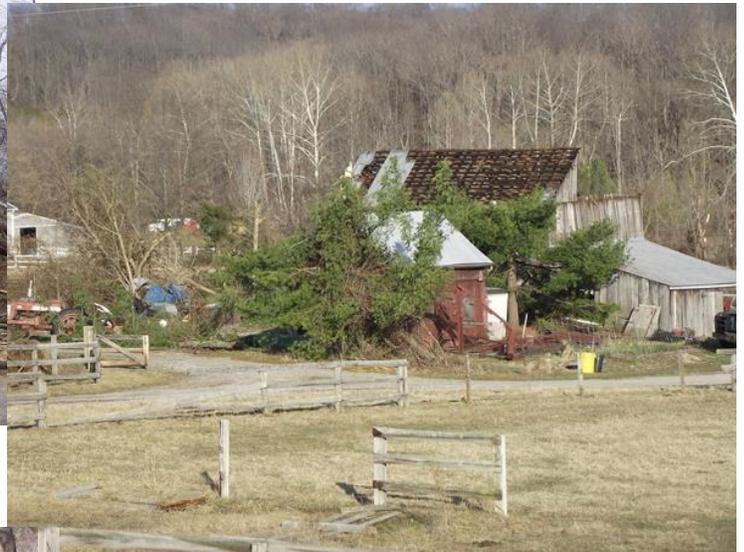
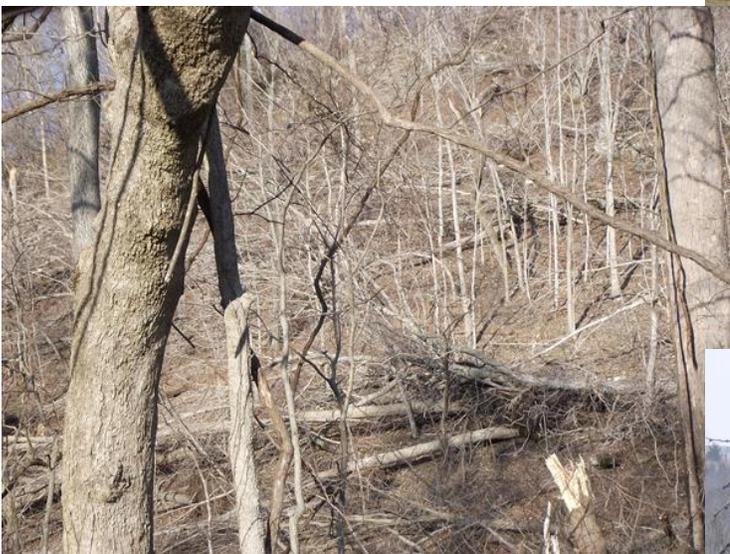
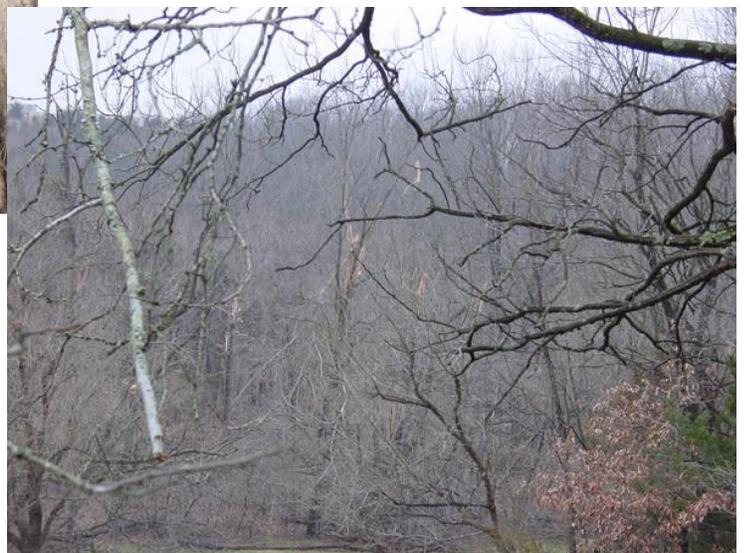
Personnel from the National Weather Service Forecast Office in St. Louis investigated the storm damage that occurred across parts of western St. Louis County on Sunday evening February 27th. The damage was a result of five short-lived EF1 tornadoes. Much of the damage was located in and near Babler Memorial State Park.

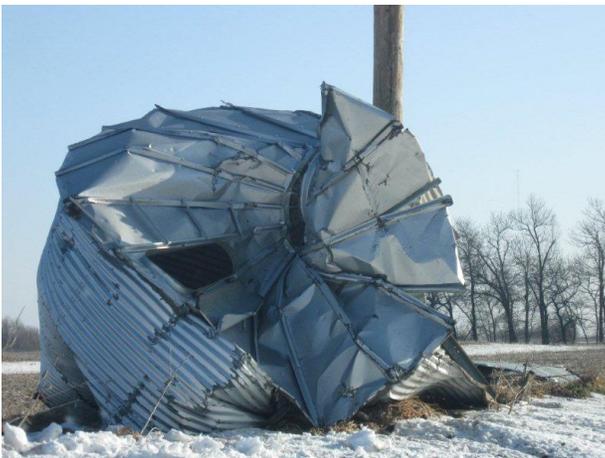
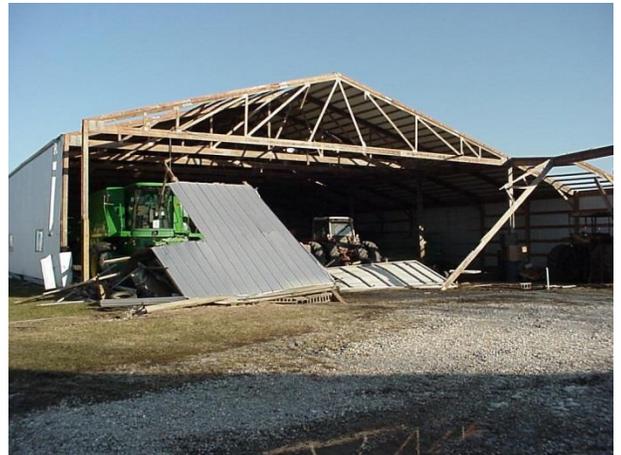
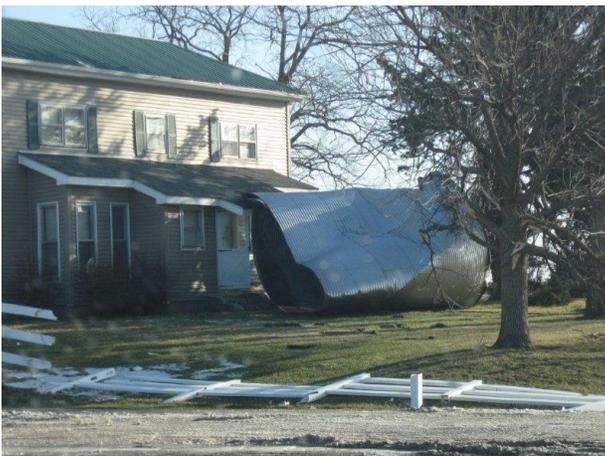
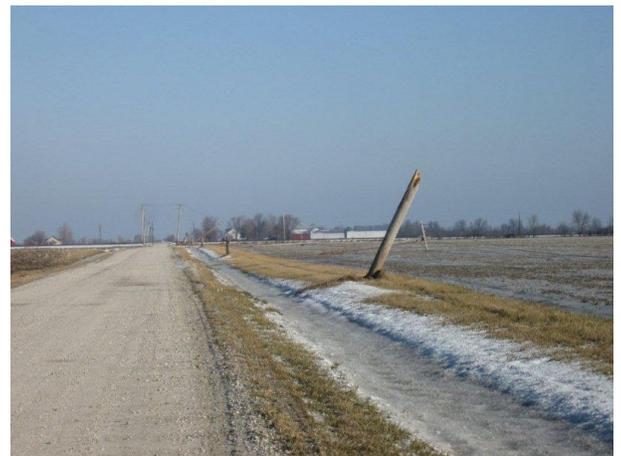
One tornado initially touched down 1.5 miles south of Shelbina just west of Highway 15, damaging a small storage building and scattering debris across Highway 15. The tornado then continued to the east-northeast, severely damaging a large metal farm building. The debris from this building was blown downwind over one-half mile. The maximum damage was rated EF1, with a maximum wind speed around 90 mph. Total length of this tornado was around 1 mile, with a maximum width of 20 to 30 yards.

Another tornado initially touched down just southwest of the intersection of Highway 15 and Route WW, damaging several metal machine sheds and tossing debris over one quarter mile downwind. The tornado continued moving east-northeast, striking a farmstead just north of County Line Road. At this location two small grain bins were destroyed, one of which was wrapped around a power pole one-quarter mile to the east. A larger grain bin was partially shifted off its foundation, and suffered a partial collapse on its west side. A nearby windmill was also destroyed. The maximum damage was rated EF0, with a maximum wind speed around 80 mph. Total length of this tornado was 0.8 miles, with a maximum width of 20 yards.

In addition to the tornadoes it was also apparent that damaging straight line winds occurred throughout the area, primarily on an axis from 3 miles southwest of Shelbina to 3 miles east of Shelbina. The strongest straight line winds, approaching 90 mph, appear to have occurred east of Shelbina and just south of Highway 36, where power poles were snapped off by the high winds. Just north of Highway 36, the west side of a large machine shed also suffered significant straight line wind damage.

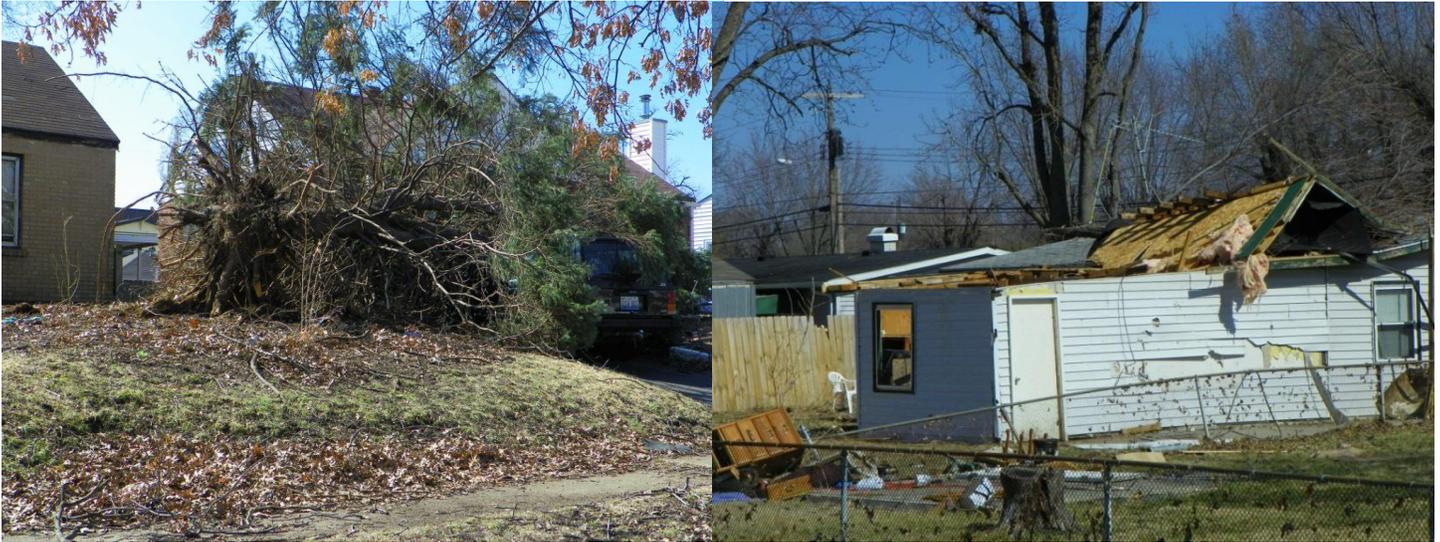
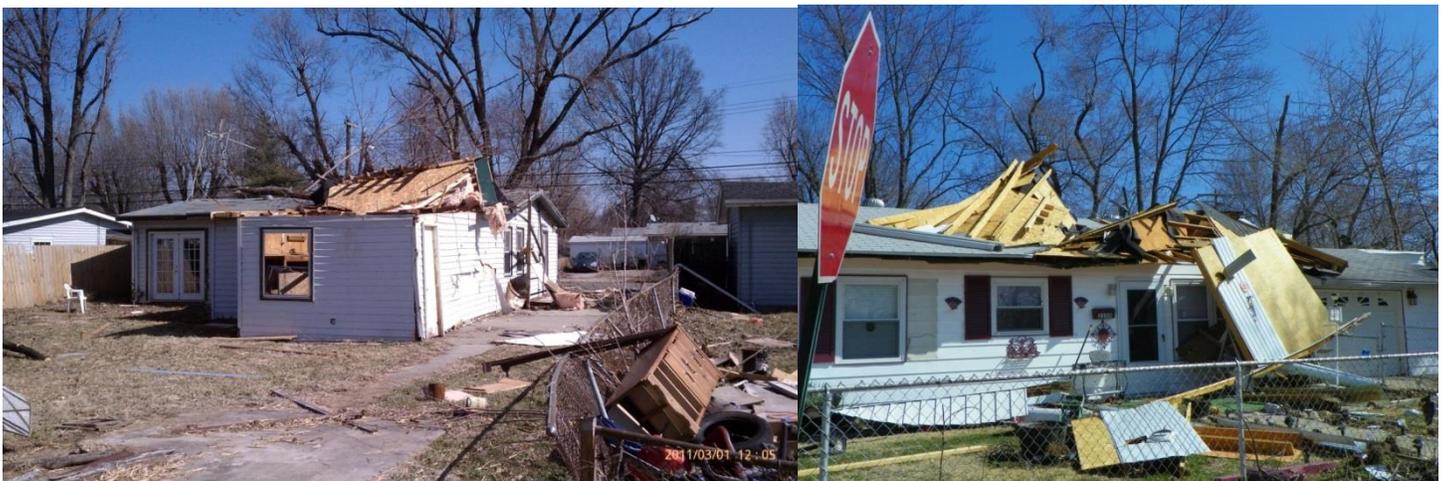
A National Weather Service Storm Survey Team investigated storm damage in Granite City in Madison County, Illinois from the storms that occurred on February 27th. It was determined that an EF1 tornado cut a 100 yard wide, 3 mile long path through the city. The tornado first touched down at approximately 11:35 PM near the intersection of Illinois Route 3 and Rock Road. There, a large storage facility lost much of its roof. The tornado rapidly moved eastward at nearly 60 mph, causing significant tree and roof damage. The tornado reached Maryville Road at around 11:38 PM where it dissipated.

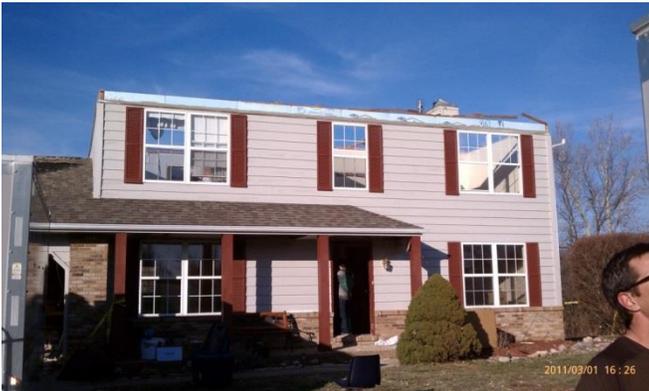
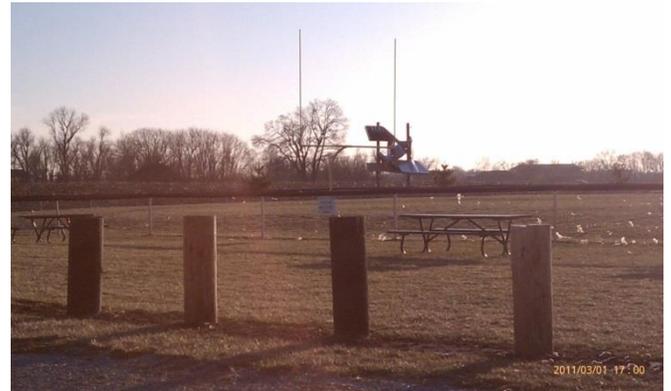
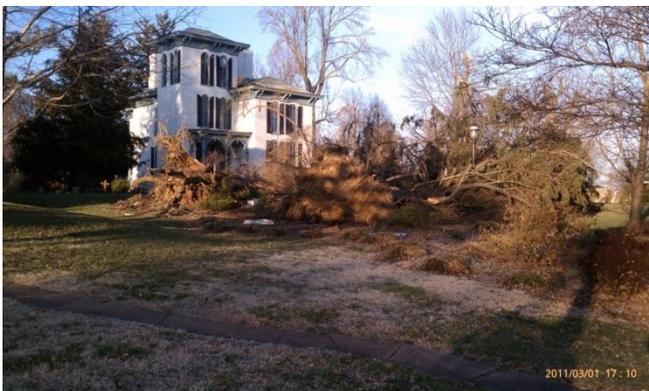
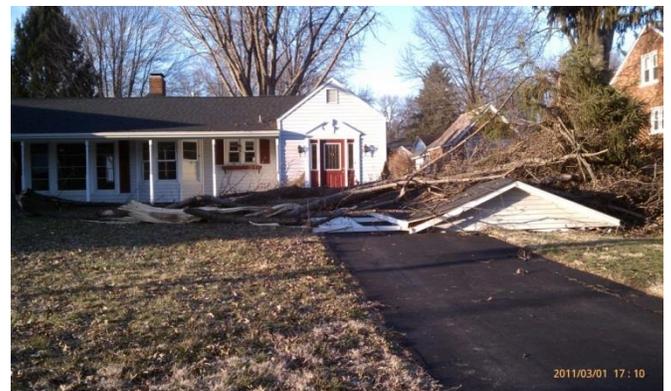
A National Weather Service Storm Survey Team investigated storm damage in Troy in Madison County, Illinois from the storms that occurred on February 27th. It was determined that a tornado touched down on Weathervane Road on the west side of town at approximately 11:45 PM. It was there that the tornado was at its strongest, an EF2, as it completely removed the roof from a well constructed home. One occupant received a serious head laceration and was treated at a local hospital. The tornado moved eastward at 60 mph, with a damage path of 100 to 200 yards wide. The tornado continued to near the intersection of North Dewey Street and East Clay Street, where it lifted at approximately 11:48 PM. The path length was 2.7 miles long.

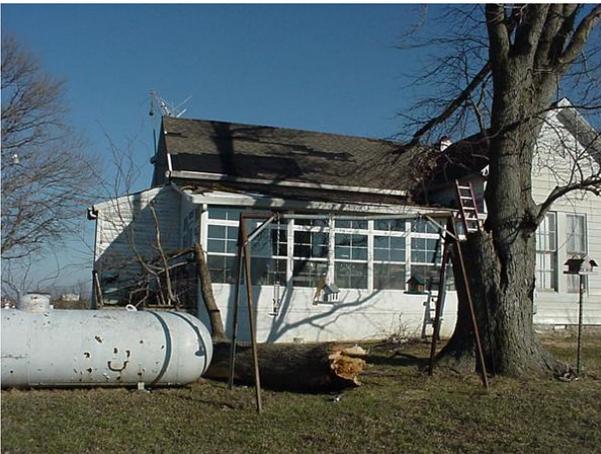
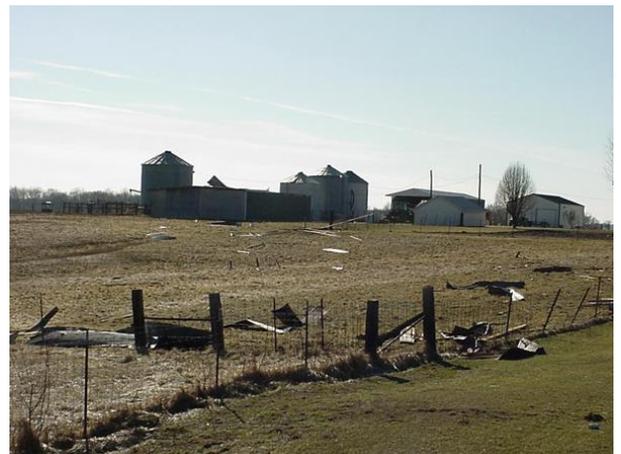
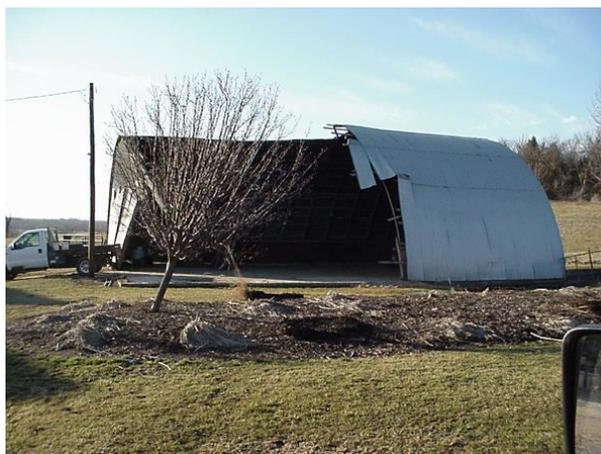
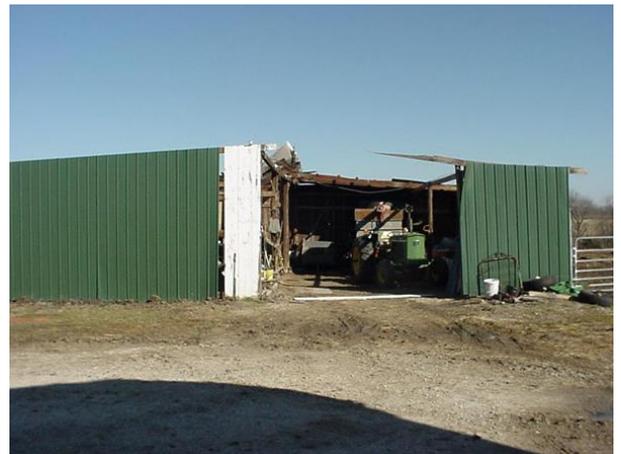
The first tornado initially touched down at approximately 9:05 PM on County Road 122 between Highways B and YY. A narrow swath of tree damage was found at this point. Several large pine trees were severed about half way up the trunk. The tops of the pine trees could not be found. The tornado skipped and caused additional tree damage 1/4 mile south of intersection of County Road 120 and Highway B. The final area of tree damage was found crossing Highway 79 approximately 1 mile east of the intersection of Highways B and 79. The width of the damage area ranged from 30 to 40 yard and was rated EF0. The damage track length was approximately 2.3 miles.

The second tornado initially touched down just south of Highway B, 1.9 miles east of Frankford, Missouri at approximately 10:05 PM. A machine shed was severely damaged at this location, and several missiles from the machine shed were embedded into the ground. This tornado destroyed three more machine sheds along its path. Debris was tossed between 1/4 to 1/3 mile to the east-northeast. The width of the damage ranged from 30 to 40 yards while the length of the tornado track was 1.4 miles. The damage was rate EF0.

Another path of straight line wind damage was found just south of the second tornadic damage track. Damage to silos, medium to large trees were damaged, along with three homes were found. This damage area extended along and south of Highway B to County Road 123 and west of County Road 124. Shingles were mainly removed from the roofs of the three homes while both pine and oak trees were either snapped at the base or uprooted. Winds ranged from 65 to 75 mph over this area. The wind damage occurred between 10:00 and 10:10 PM.

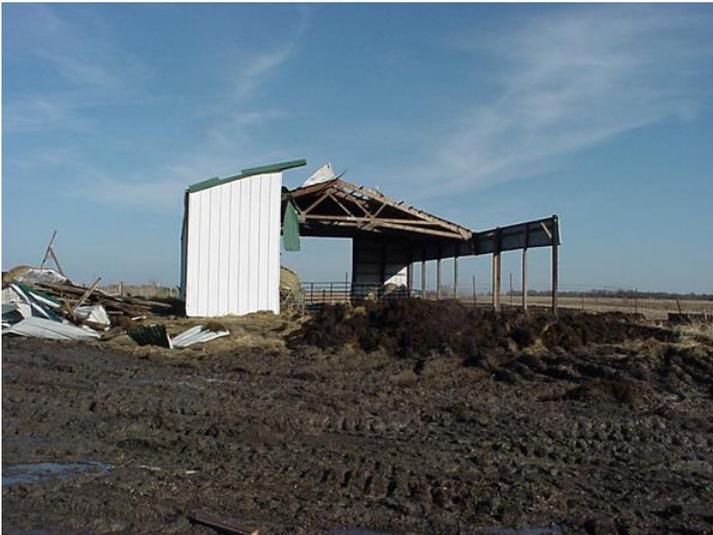
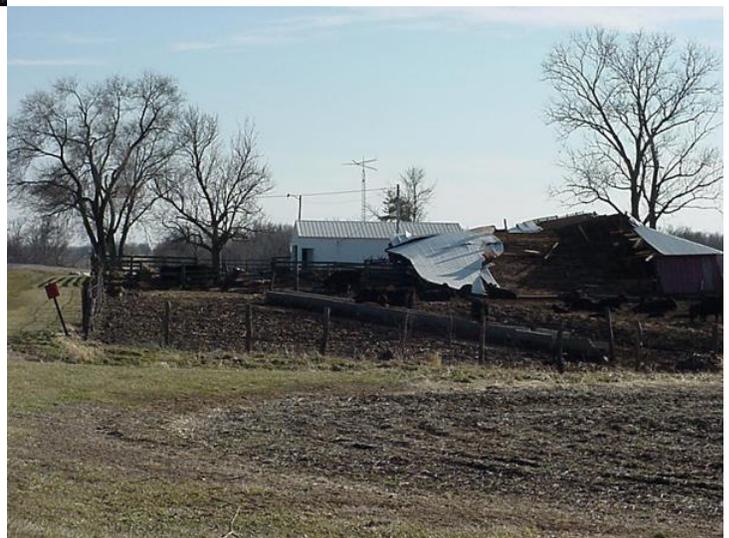
The wind damage began east of Perry, just east and southeast of the intersection of Highway 19 and 154, and spread east to Highway F near the Ralls-Pike County border. The damage path was about 9 miles long, with a width of approximately 5 miles. Eyewitness accounts indicate that these high winds occurred in the 9:50 to 10:00 PM time frame. The damage that occurred in this swath suggest the area experienced strong straight line winds of 60 to 75 mph, with localized areas of much more intense winds that produced extreme damage. These areas of intense winds are called microbursts, and the damage indicates that the winds in some of these microbursts exceeded 100 mph.

On Highway Y, 5 homes sustained varying degrees of damage, from the loss of a few shingles to the partial removal of roofing material down to rafters. The most extreme damage on Highway Y was to a barn that was totally flattened, and its debris was tossed to the east almost one-quarter mile. A wide variety of damage was also observed on Highway P. The greatest damage occurred just south of the intersection of Highway P and County Road 234, where one barn was flattened, another shed sustained major damage, and a third outbuilding sustained moderate damage. To the east of this area, 4 high voltage power poles were snapped by the high wind. On Highway F, 2 to 3 miles north of Vandalia, a series of power poles were snapped off and pushed over by the extreme wind. Previous engineering studies have indicated that it takes winds of over 100 mph to snap this type of a power pole.

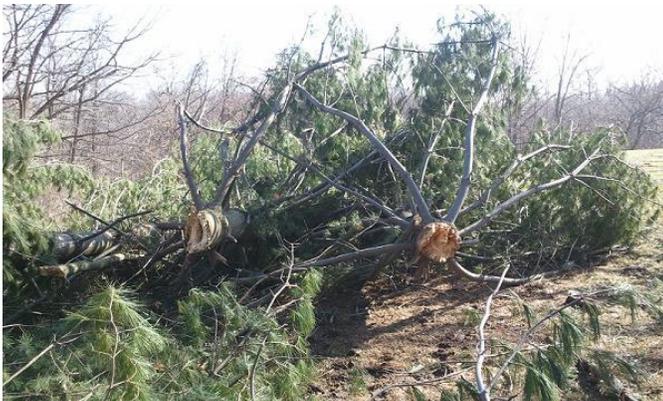
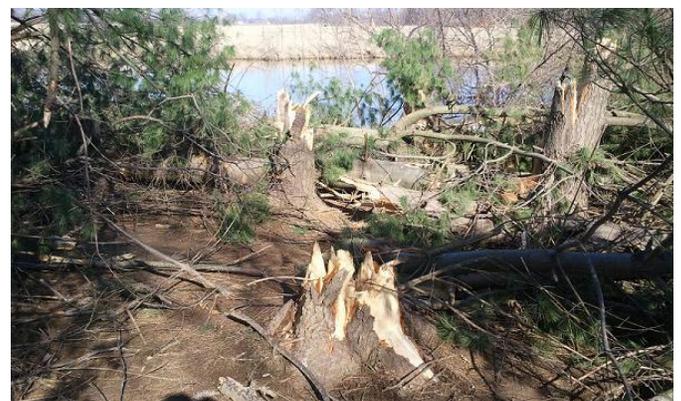
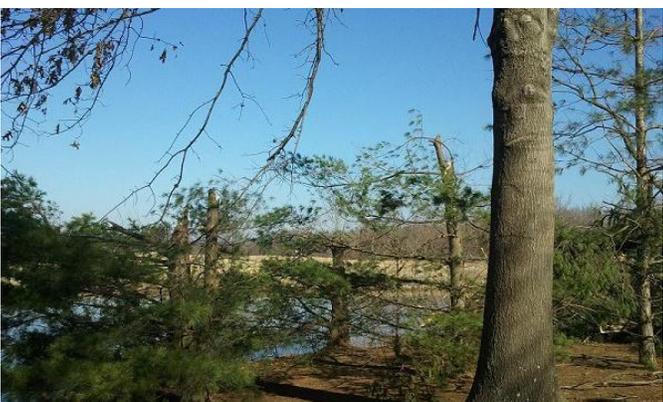
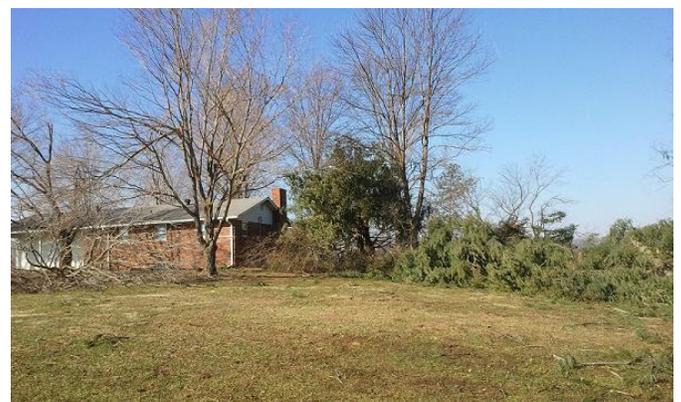
A tornado touched down approximately 2.5 miles north of Pocahontas at a farm and residence along File Avenue. A concentrated area of extensive tree damage was found next to a house. Every hardwood and softwood tree in this area was snapped at the trunk. Tree tops were thrown 30 to 50 yards. Several trees were also uprooted. The house sustained shingle damage and two supporting posts on the house were blown out. A granary was destroyed with debris thrown between 50 and 100 yards. A large metal storage shed lost its roof and two walls were blown out with debris scattered between 1/4 and 1/2 mile. The tornado skipped east, hitting another farmstead on Shawnee Road, causing damage to a silo and roof. The debris was tossed to the north over 300 yards. The maximum damage was rated EF1 with a maximum wind speed around 100 mph. The total length of the tornado was 2.7 miles with a maximum width of 50 yards.

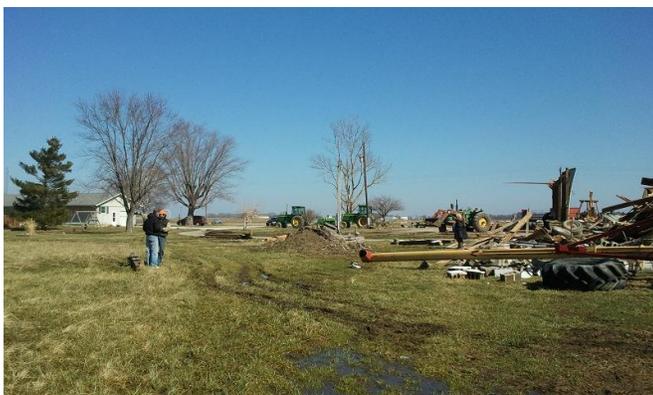
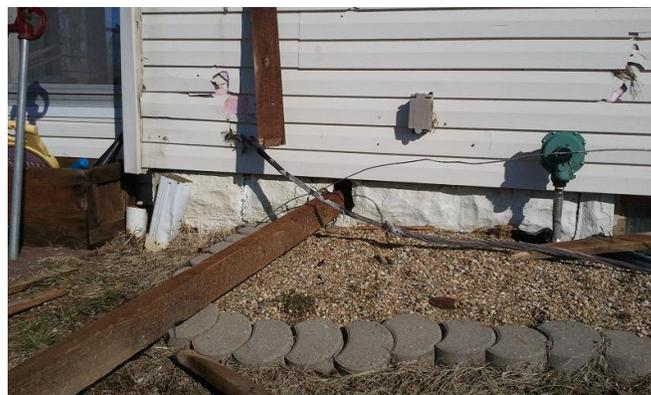
A tornado touched down in Confidence, Illinois approximately 8 miles southwest of St. Elmo or 9.5 miles east-southeast of Vandalia. The tornado touched down near County Road 1750 East and County Road 1275 North and damaged a residence, trees, and outbuildings. A convergent pattern was found in the debris. The tornado then continued east northeast and damaged several residences and farm buildings along County Road 1275 North. One residence was shifted 22 feet off the foundation and another was shifted 6 feet off the foundation. Lumber from the roof was driven into the siding and into the foundation at a third residence. The tornado then skipped through a wooded area north of County Road 1275 North before lifting west of Route 185. The maximum damage was rated EF2 with a maximum wind speed around 120 mph. The total length of this tornado was approximately 1.3 miles with a maximum width of 90 yards.

Another tornado briefly touched down near the County Line between Fayette and Effingham Counties approximately 0.2 miles south of County Road 1800 North. Two large farm buildings were destroyed and debris was thrown 1 mile to the east into Effingham County. Other farm buildings also sustained damage. There were four spots on the property with evidence that heavy debris, including a cinderblock, was thrown a substantial distance to the northwest. Several 2X4s were driven several feet into the ground. The maximum damage was rated EF2 with a maximum wind speed around 115 mph. The total length of this tornado was 175 yards with a maximum width of 50 yards.

A tornado also briefly touched down approximately 1 mile southeast of St. Elmo at a farm building located 0.1 miles south of Interstate 70 and 0.2 miles north of County Road 1900 North along County Road 2250 East. The south facing wall of a large metal farm storage building was blown out with debris scattered over one half mile into an adjacent field. Several 2X4s were driven several feet into the ground. A billboard just south of the farm building supported by 16 wooden posts, each 5 to 10 inches in diameter. All of these posts were snapped but there was no damage to the power poles directly across the road. Since the billboard was found on the road directly in front of the posts rather than farther downstream, it appears that straight line winds caused damage to the billboard while the tornado was responsible for damage to the farm building. The maximum damage was rated EF1 with a maximum wind speed around 95 mph. The total length of this tornado was 120 yards with a maximum width of 10 yards.

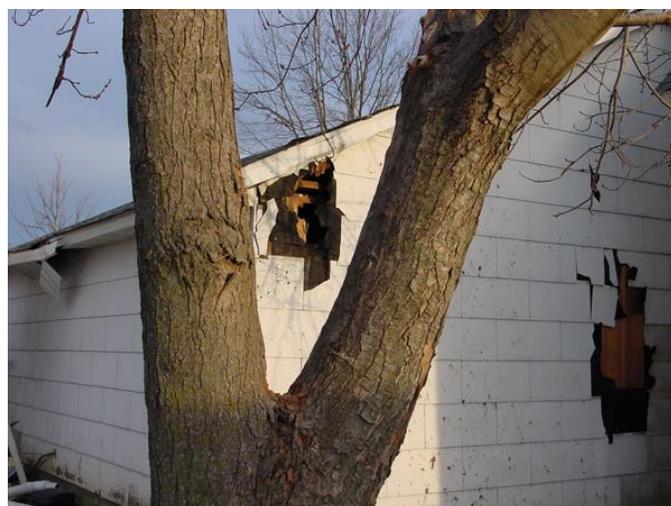
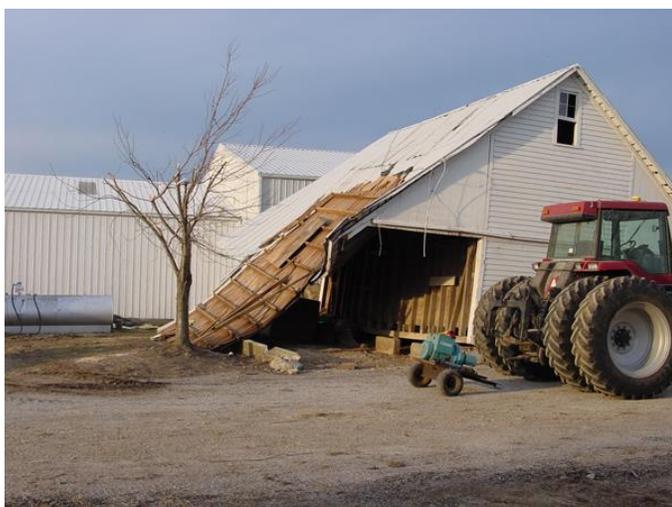
The first tornado in Washington County formed just to the southwest of Okawville. The tornado moved across the south side of town and damaged the local grain elevator, produced some minor roof and exterior damage to houses along the south side of East Schumacher Street. The Emmanuel Lutheran School also sustained some minor roof damage. The tornado continued to the east where it produced some additional damage and snapped a 8-10 inch diameter tree trunk approximately 6 feet off the ground. The tornado continued east until it damaged a house on Hummingbird Road. This house suffered an unknown amount of roof damage because it was in the process of being repaired. There was also minor tree damage and an outbuilding that was destroyed with the debris scattered several hundred yards to the northeast. The tornado lifted just to the east of this location. Path length was 2.8 miles with a maximum width of 50 yards and rated EF0.

The second tornado in Washington County started approximately 6 miles east of Okawville on Illinois Highway 177 near the Kuhl Lumber and Pallet Company. Minor roof and siding damage occurred to an ongoing construction project at the saw mill. A few trees along a tree line to the east of the complex were topped. The tornado continued east where it struck a farmstead causing considerable damage. A 48 by 96 foot machine shed was completely destroyed with much of the debris scattered up to almost one mile to the east. Another building was lost at this location as well as a grain bin. Two other barns sustained damage with one being pushed off the foundation by several feet. The debris from the machine shed impacted the house, garage and workshop with several missiles not only in the ground but also into other structures. The home sustained several broken windows from flying debris. The roof of the home had at least five rafters damaged when an unknown heavy object hit the roof, but was blown away during the storm. The tornado continued to the east and dissipated approximately one mile from New Minden. The path length was 2.3 miles with a maximum intensity of EF2 due to the damage at the farmstead. Maximum damage width was 100 yards.

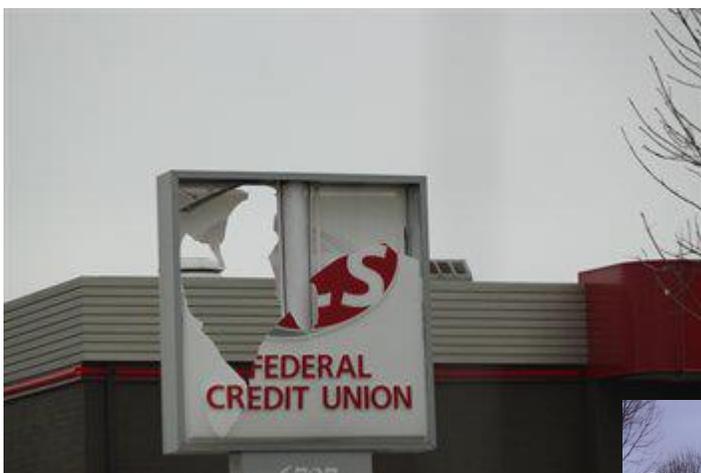
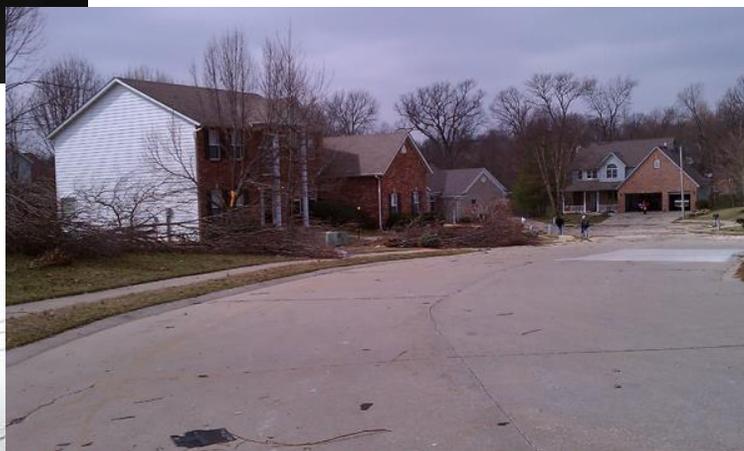
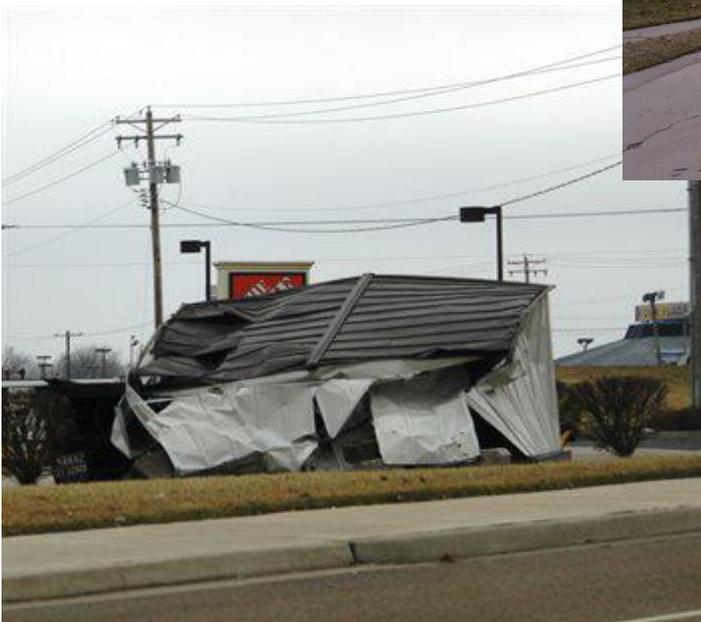
The tornado in Madison County first touched down between Edwardsville and Glen Carbon near the intersection of Ginger Creek Drive and Illinois Highway 157. There were several cedar trees uprooted at this location. The tornado continued east-northeast through the Ginger Creek Subdivision to the intersection of Center Grove Road and Illinois Highway 159. This is where a metal industrial building sustained roof and siding damage. The tornado also crossed the intersection of Center Grove Road and Troy Road where a few signs of local businesses were damaged and a Home Depot sustained some damage to small reconstructed sheds sitting outside. The tornado continued east-northeast to near the intersection of Gerber Road and Governors Parkway where several houses sustained minor roof and siding damage. The tornado dissipated just beyond this location. The path length of this tornado was 2.4 miles long. Most of the damage along the path was rated EF0 with the maximum intensity rated EF1 for some tree damage and the industrial building damage. The maximum path width was near 150 yards.

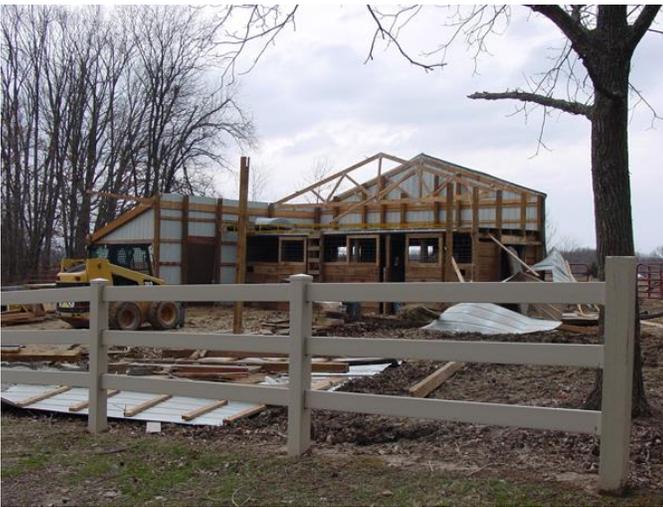
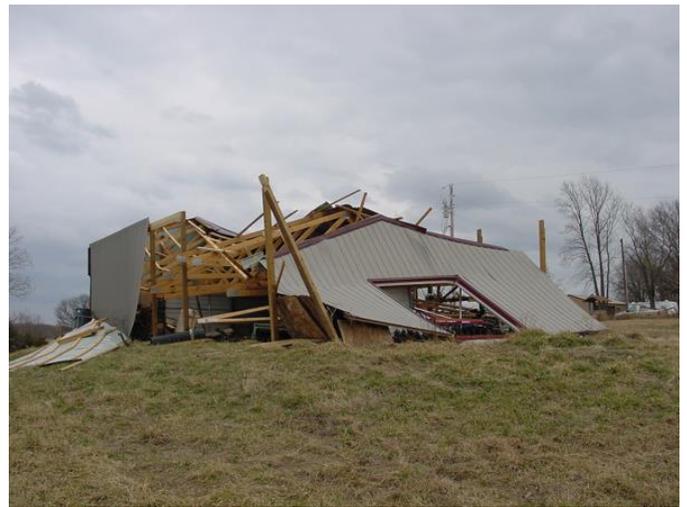
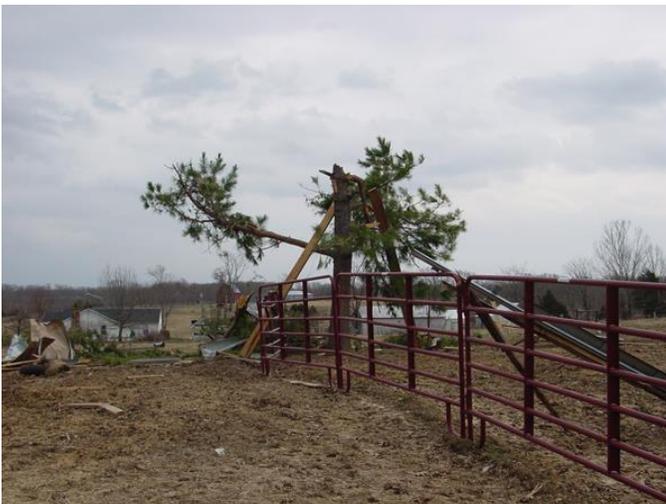
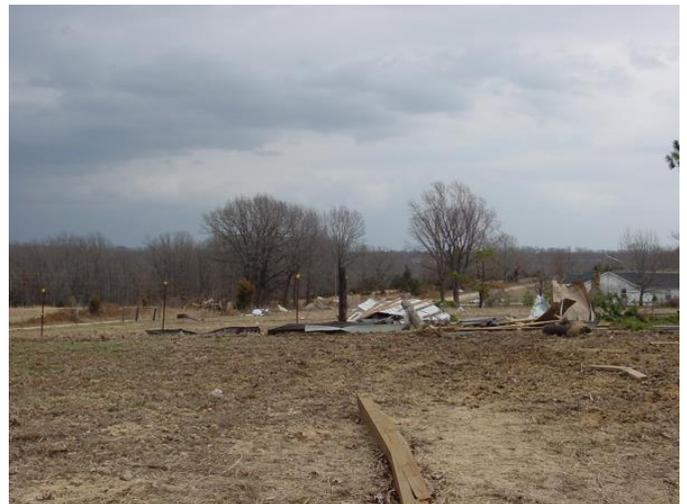
The tornado hit a farmstead around 10:10 PM one-half mile south of the intersection of County Roads 804 and 811 on a ridge. A large barn was totally destroyed while a brick ranch home had several broken windows on the west side. Roofing materials were also removed. A few trees and pines were snapped about half way up and tossed over 40 to 50 yards to the east. The width of the damage track was approximately 50 yards while damage intensity was rated EF1. The damage length was approximately one half mile. Damage intensity was rated EF1.

Also along County Road 811 on large tree fell through a house trailer cutting the trailer in half. Tree damage was also noted about one half mile to the north of the house trailer. Further east two machine sheds were severely damaged by localized high winds along County Road 806 or about one half mile east of the intersection of County Roads 806 and 807. Debris from the machine sheds extended 1/4 to 1/3 mile to the east-northeast. Winds were estimated around 90 mph over this area. The wind damage occurred around 10:15 PM.

Roof damage occurred to Fatima R3 School. Much of the roofing materials were removed from the gymnasium at the school. This damage occurred around 10:00 PM and was caused by straight line winds around 70 mph.

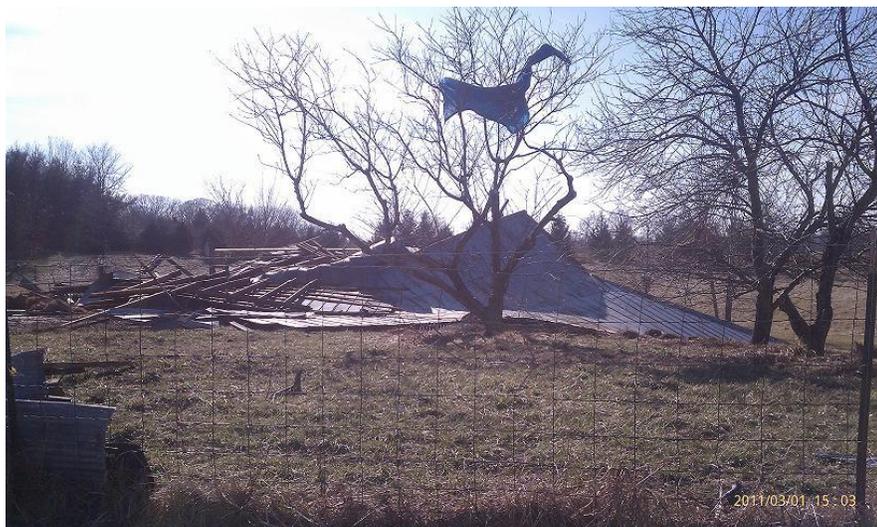
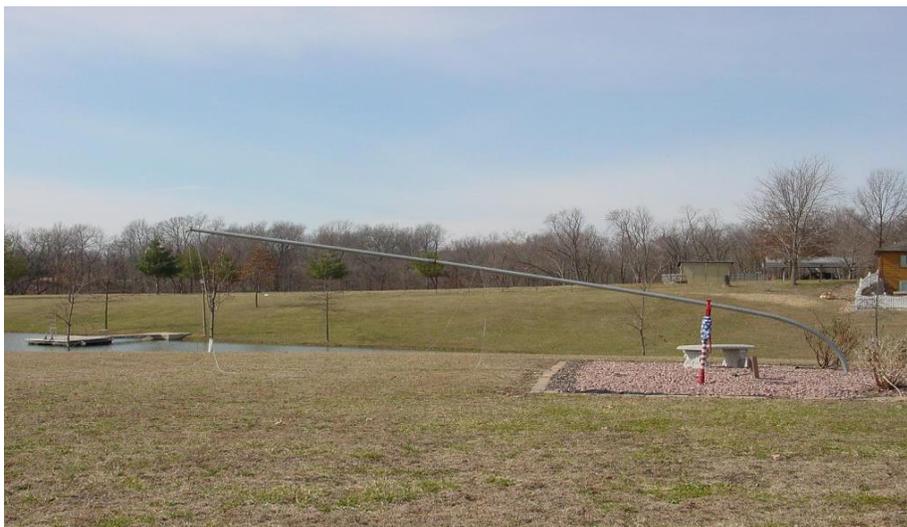
The tornado formed just west of Interstate 55 near Mick Road approximately 2 miles north of the Interstate 55/70/255 Interchange where a few power poles were knocked over. The tornado crossed Interstate 55 and produced minor tree damage. It continued east-northeast where it produced roof and siding damage to a couple of homes. One home had part of the roof decking on the south side of the house removed while another had a flag pole located well to the north of the structure bent over almost to ground level. This pole was pointing south. Further along the path, a barn was destroyed along Staunton Road with debris strewn several hundred yards across the road into an open field. The tornado continued east-northeast until it snapped several mature pine trees off several feet above the ground along Nearly Lane. The tornado dissipated before reaching Illinois Highway 4. The path length was 2.0 miles. The tornado had a maximum width of 50 yards and maximum intensity of EF1 for the destroyed barn and the snapped pine trees.

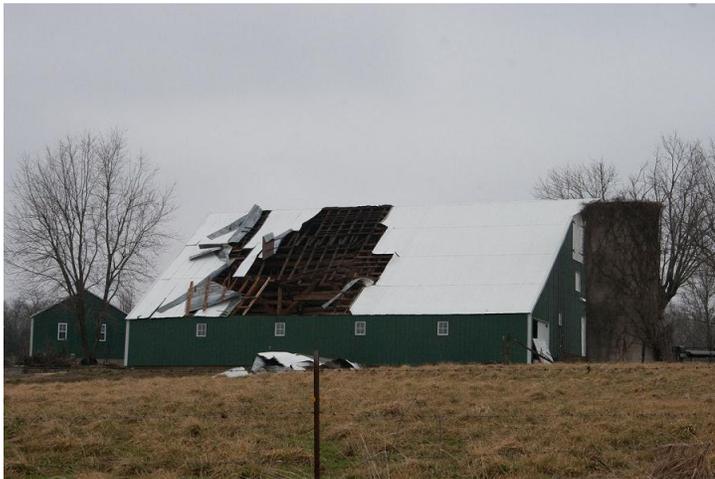
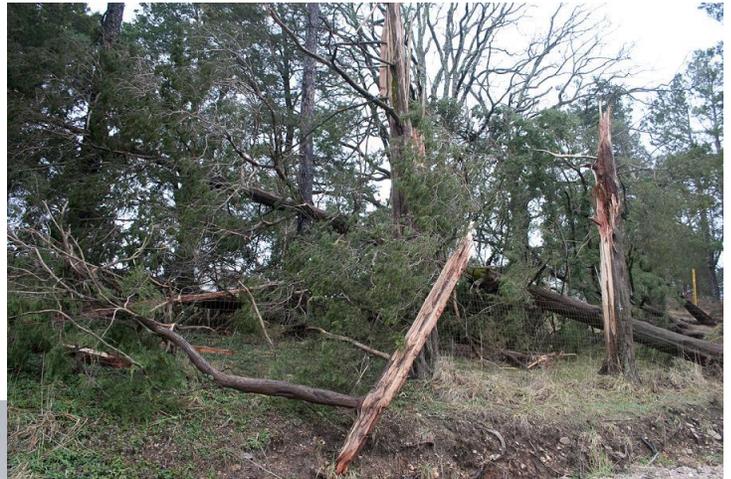
A tornado touched down about half a mile west of the intersection of Lone Grove School Road and Hesseran Road. In this location it broke off and uprooted numerous trees. As it travelled to the east it blew over a hay wagon and overturned a couple of tanks and farm equipment. A nearby home sustained minor roof damage and a shed was completely flattened. It blew over more trees before crossing Lone Grove School Road. At this location it blew part of the roof off of a large barn. It travelled a little further to the east blowing down a few more trees near Grannemann Road before lifting and dissipating. The maximum width of the tornado was 175 yards and was on the ground for three quarters of a mile. The damage was rated EF1.
