Eustis Tornado September 20, 2007

Preliminary Survey

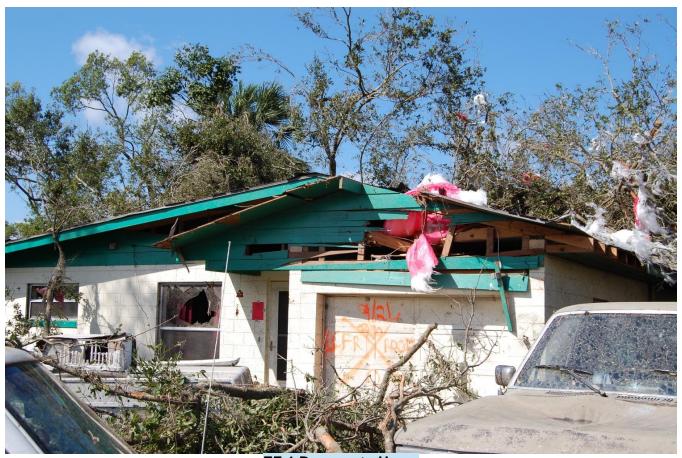
EF-1 Damage to Home

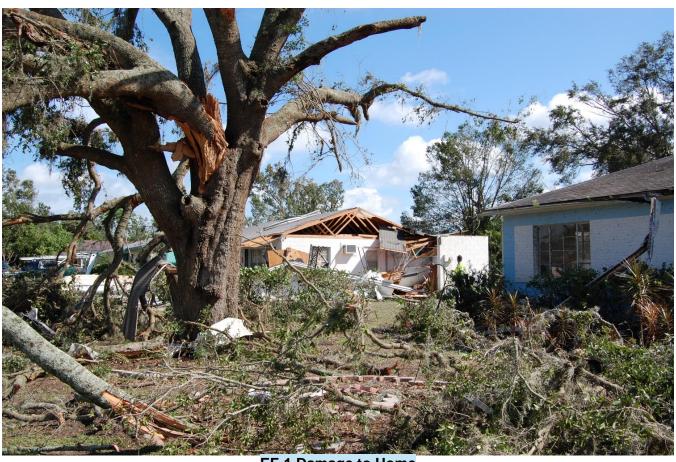
EF-1 Damage to Home

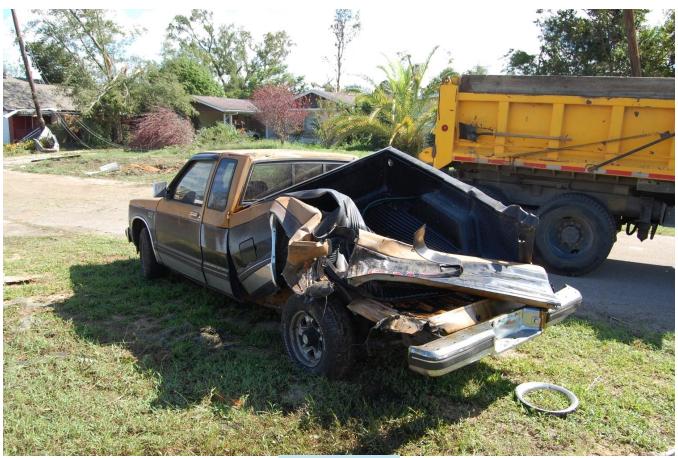
Vehicle Damaged

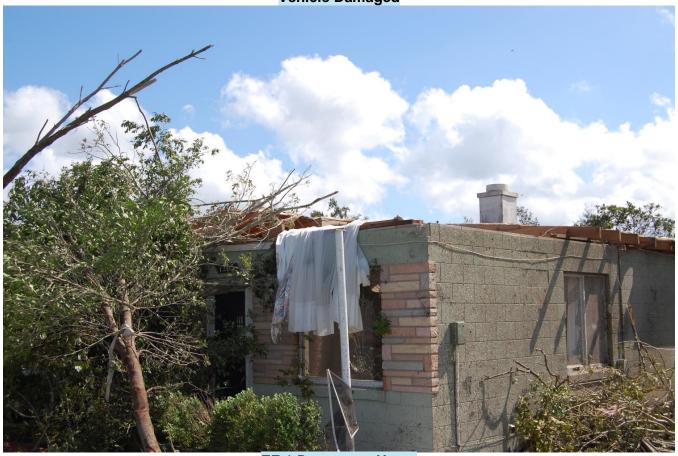
EF-1 Damage to Home

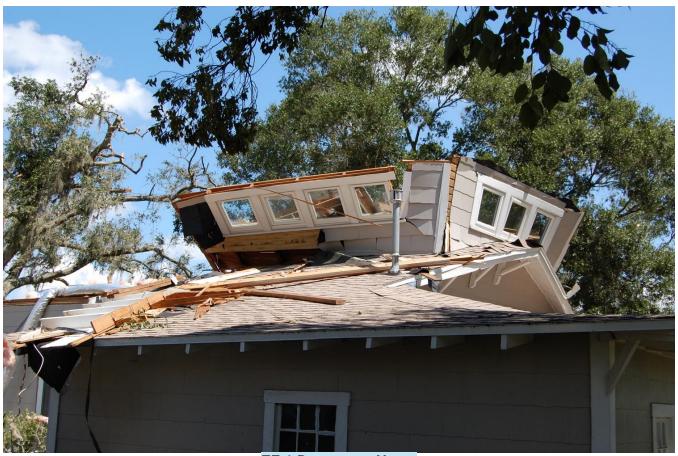
EF-1 Damage to Home

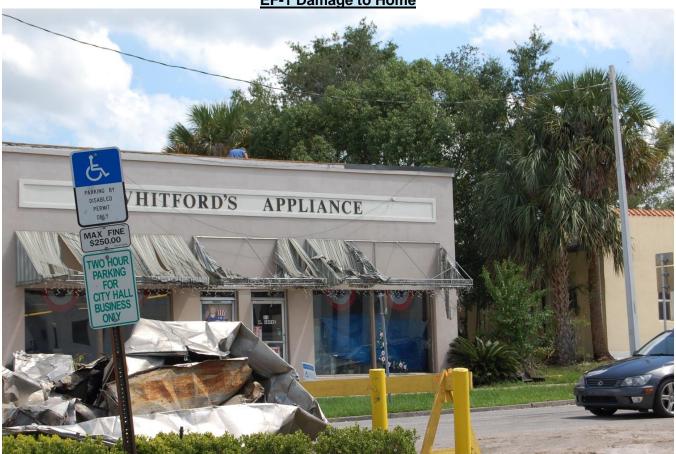
Damage Downtown
