# **North DeLand EF-2 Tornado August 18, 2020**

## **Orange City EF-0 Tornado**

### **Event Summary**

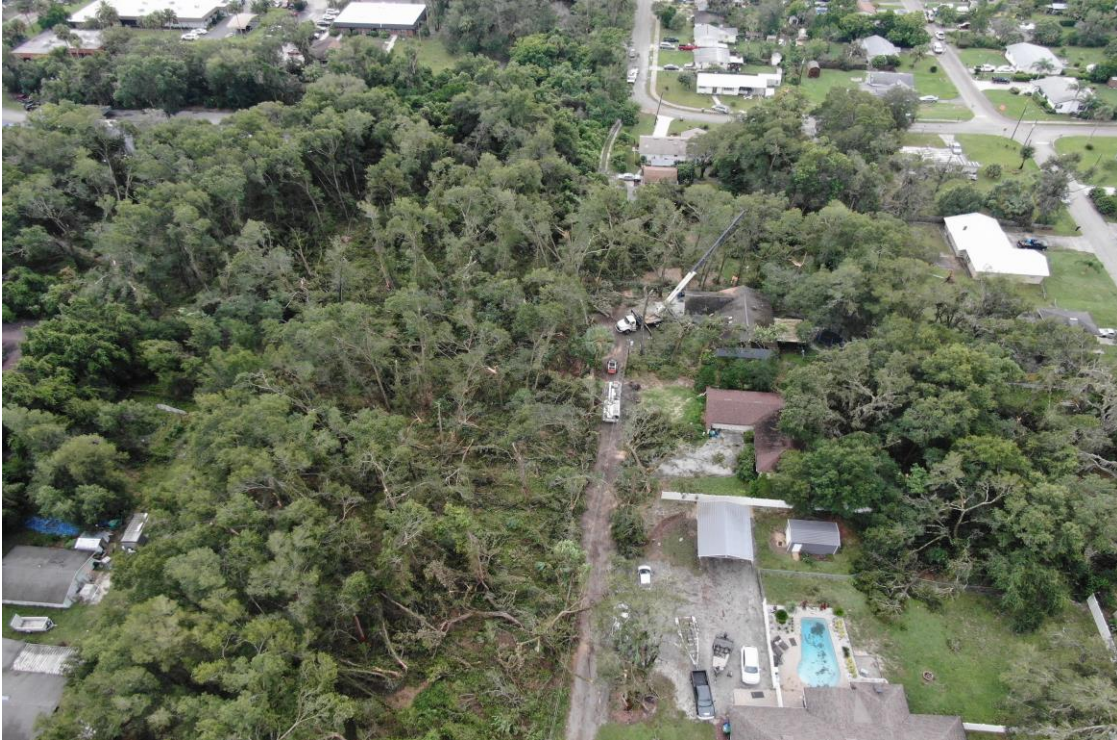
*Aerial image of tree damage along North Boundary Ave.  
(source: Volusia County Emergency Management)*

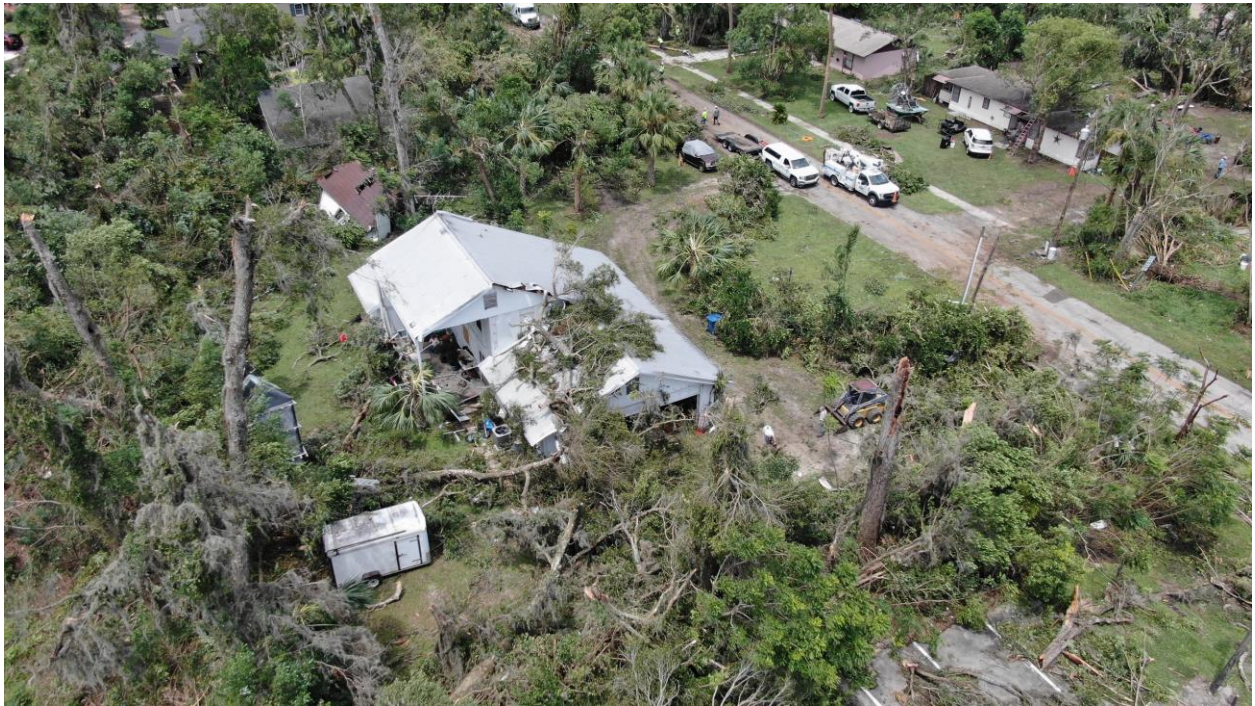
*Aerial image of tree and home damage near W Washington Ave.  
(source: Volusia County Emergency Management)*

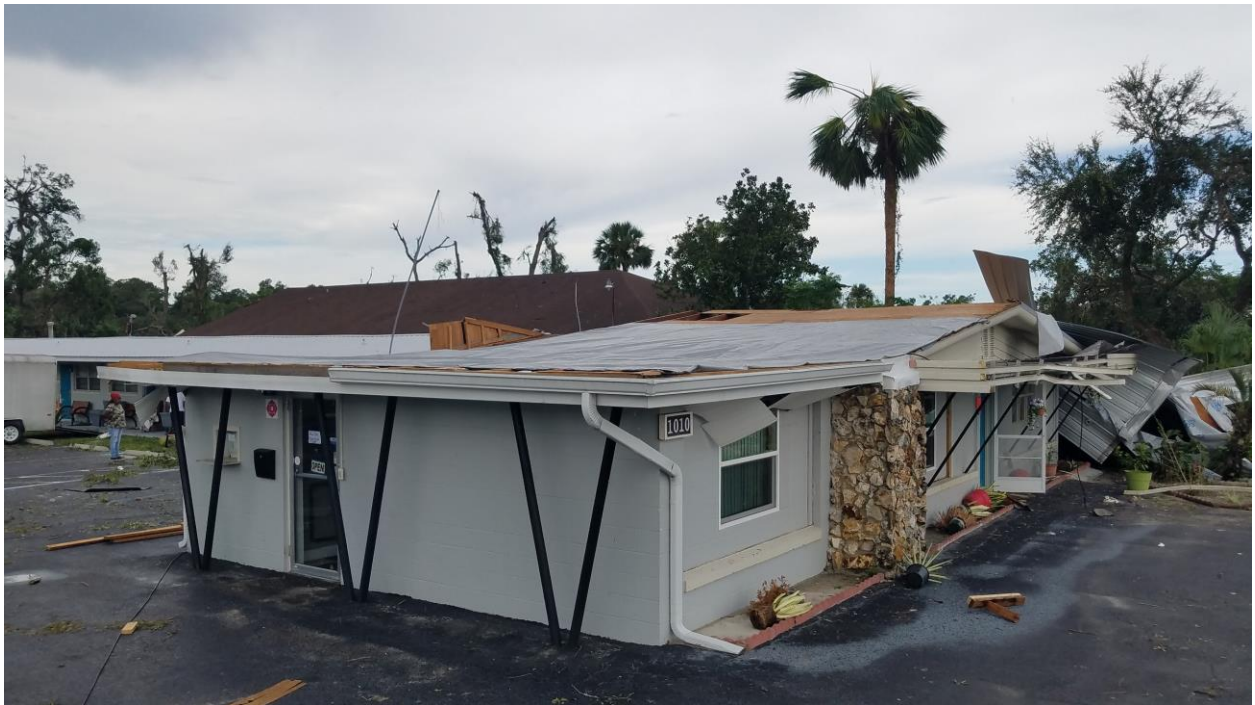
*Damage to a building along North Woodland Blvd.*

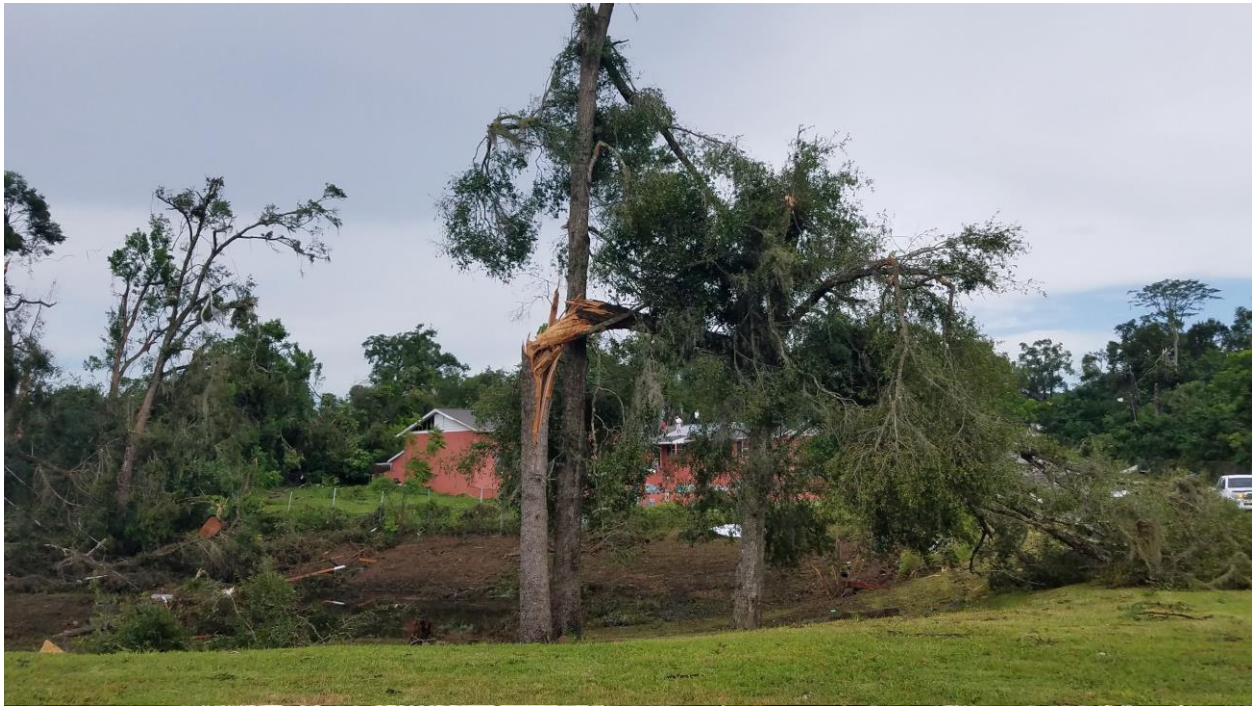
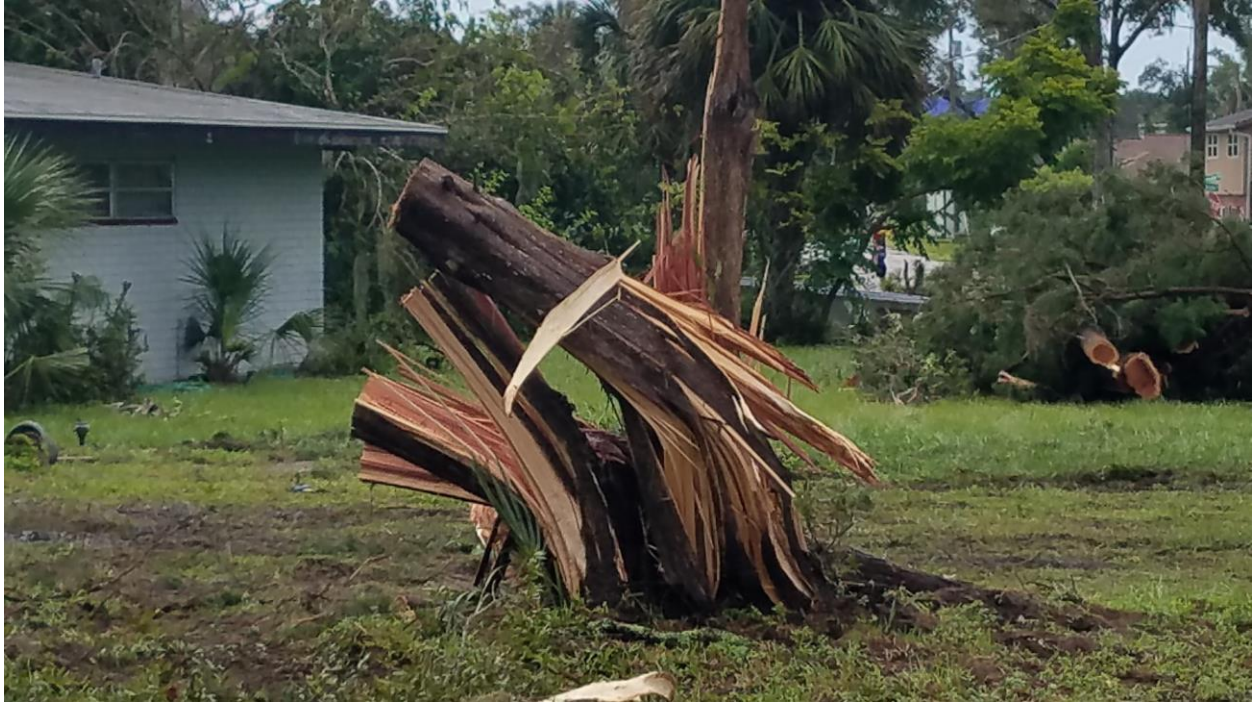
*Tree damage along E Washington Ave. and N Amelia Ave.*

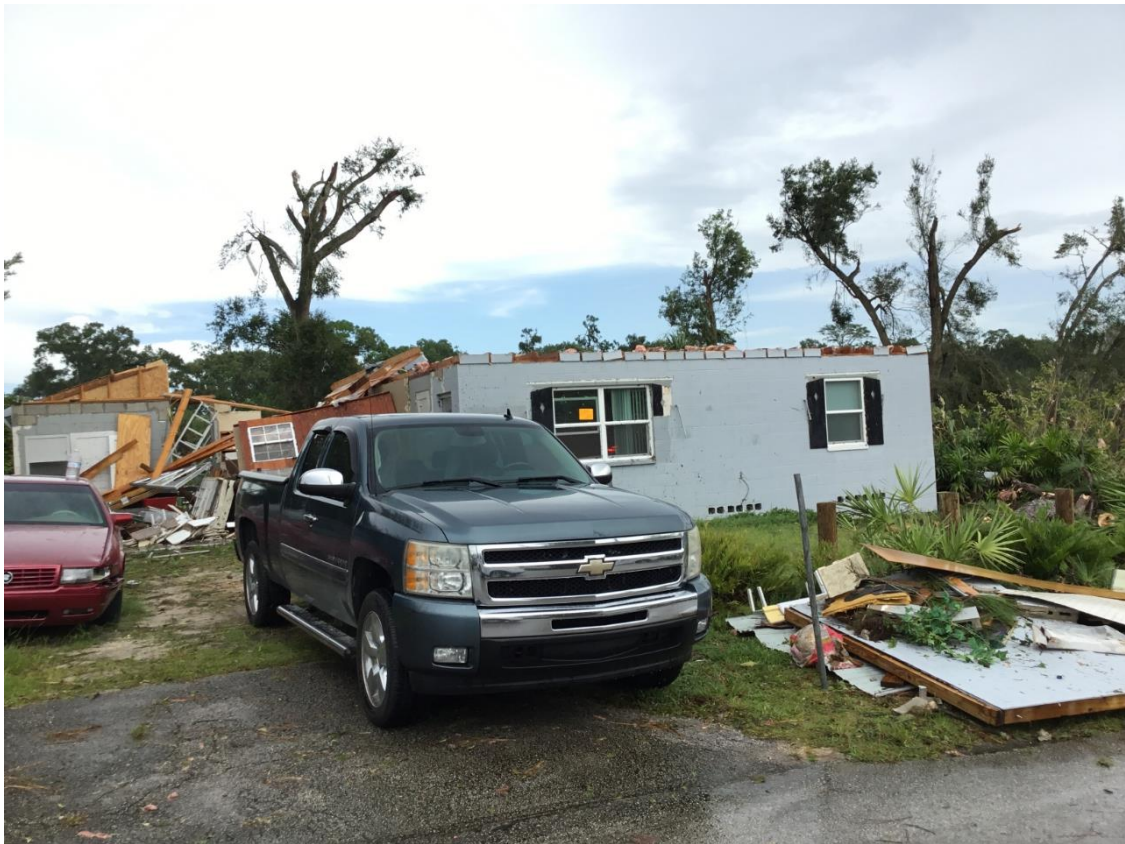
*EF-2 tornado damage to homes along E Washington Ave.*

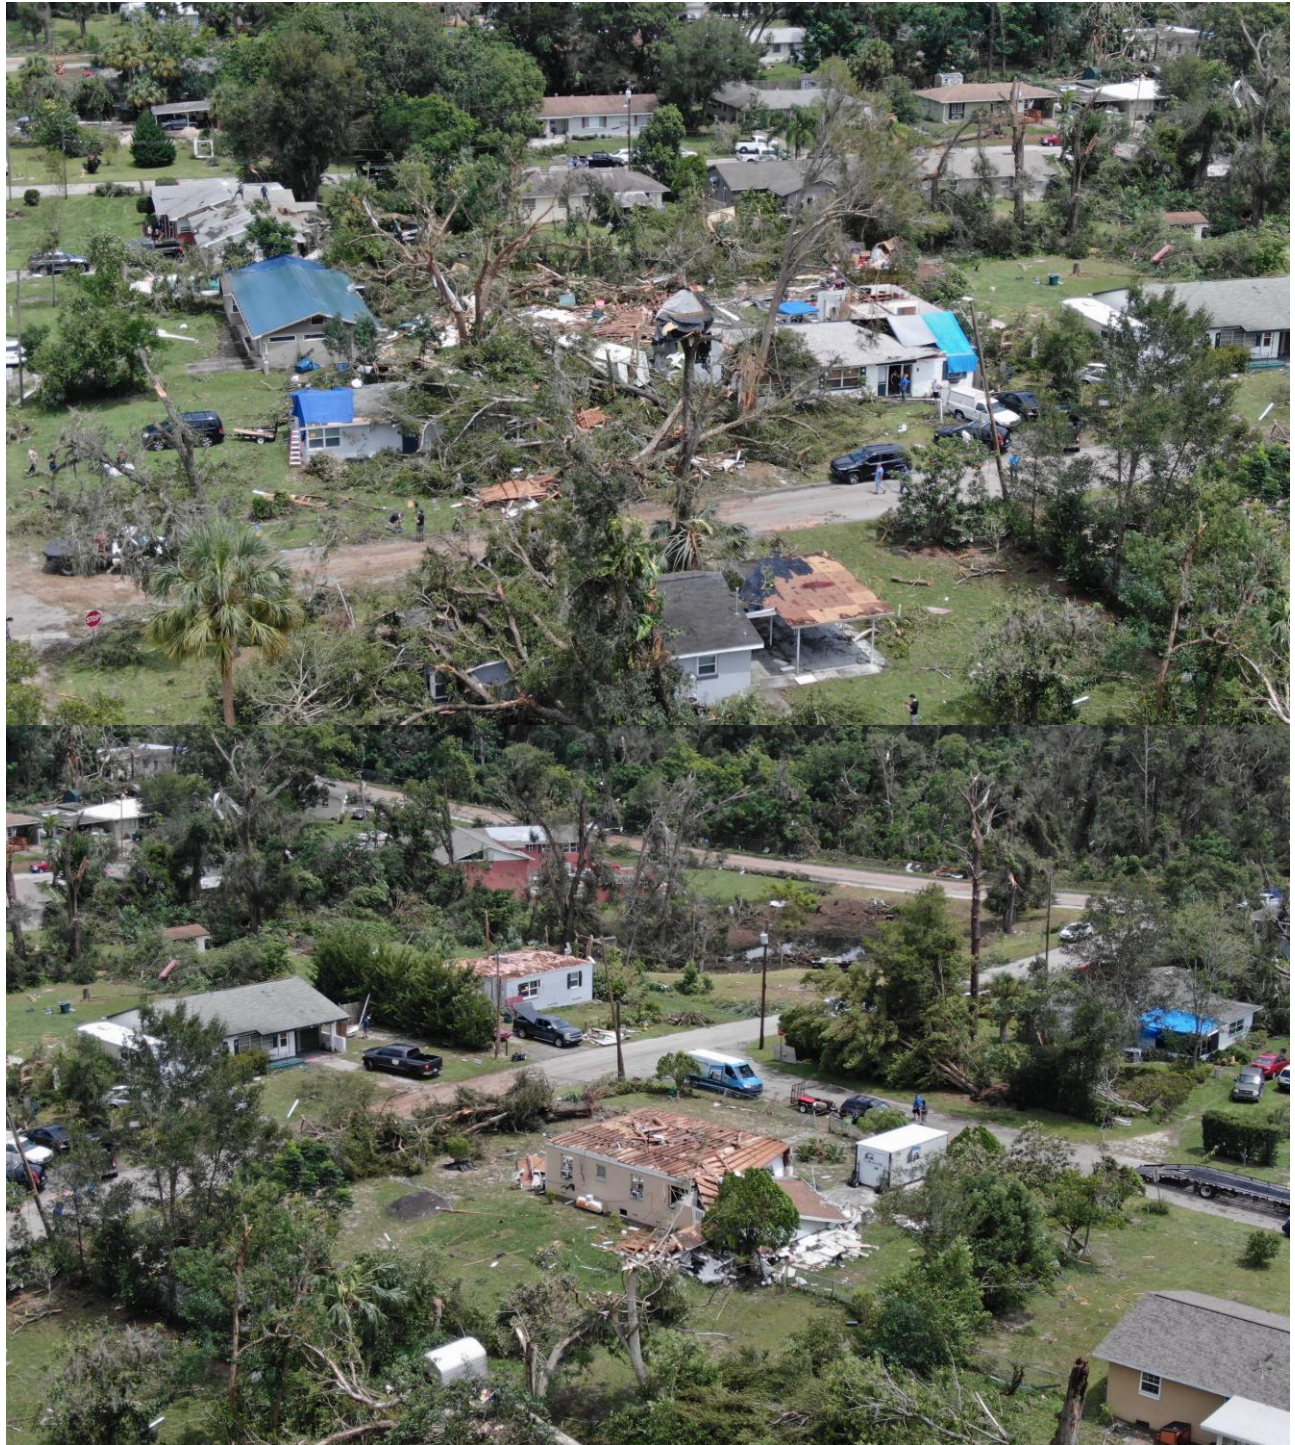
*Aerial images of EF-2 damage along E Washington Ave.  
(source: Volusia County Emergency Management)*

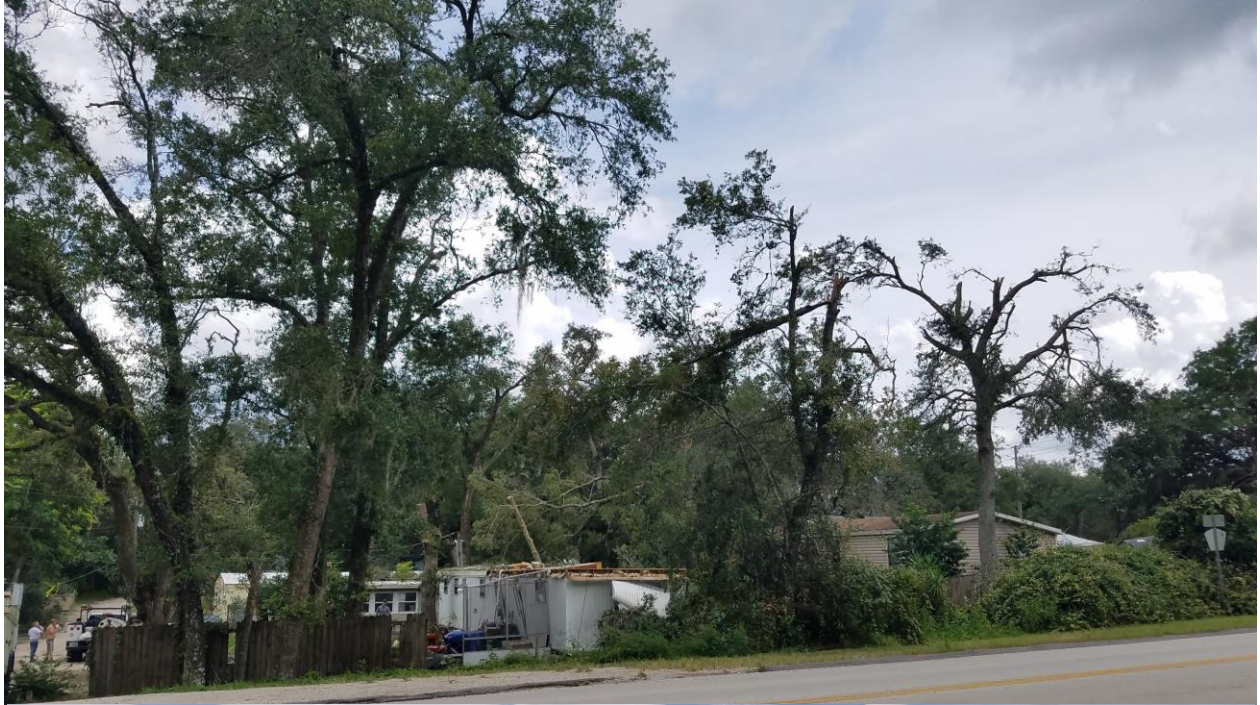
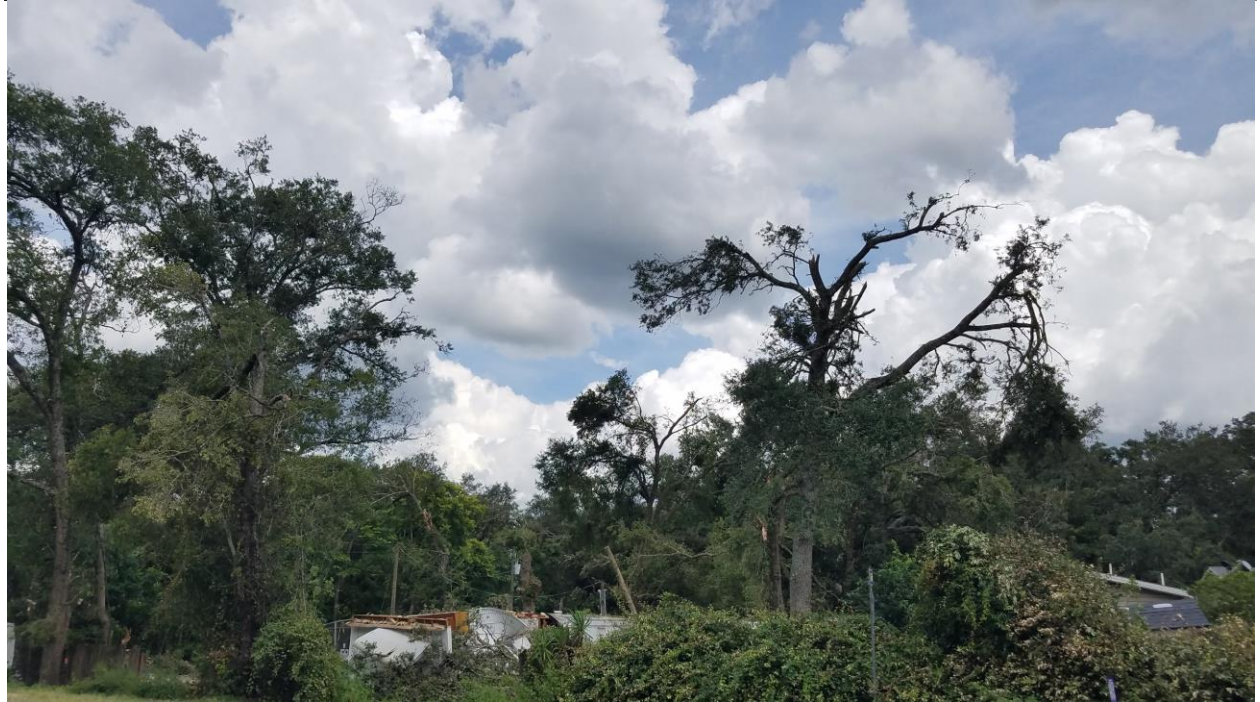
*Damage to trees and one mobile home along County Road 4101 and E Graves Ave.*
