Cocoa Beach Tornado

February 12, 2008

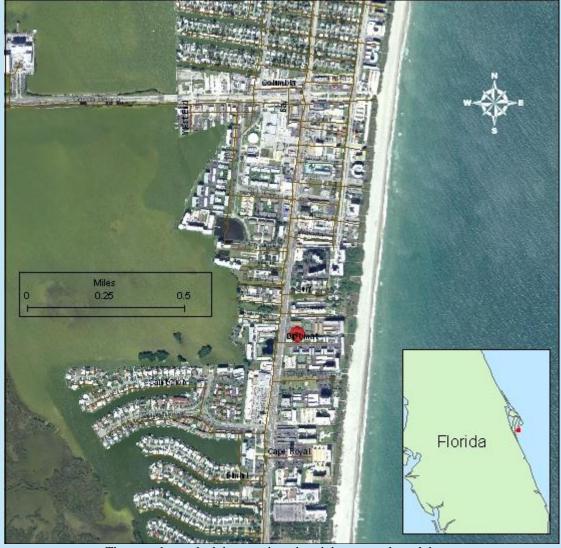
The tornado touched down and produced damage at the red dot, at 3100 N. A1A in Cocoa Beach

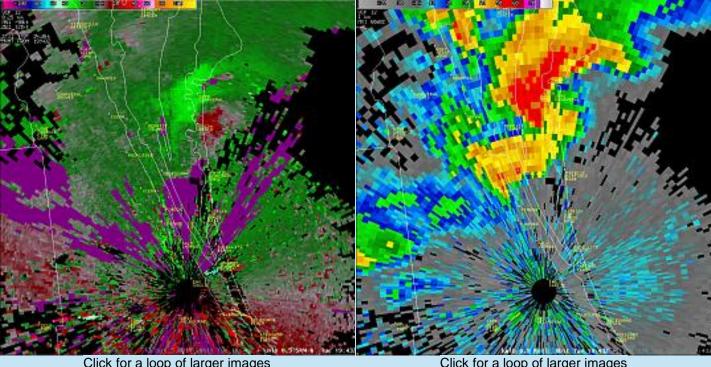
Click for a loop of larger images Storm Relative Motion at 2:43 PM (1943 GMT)

Click for a loop of larger images Reflectivity at 2:43 PM (1943 GMT)

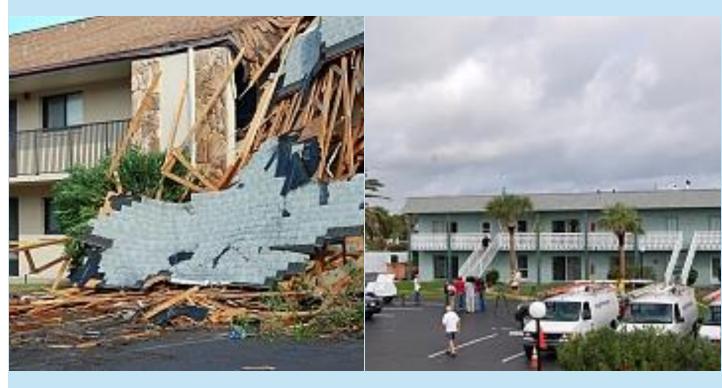
Part of the roof from Diplomat Condo where it landed on nearby Windrush Condo

Unroofed Diplomat Condo building.

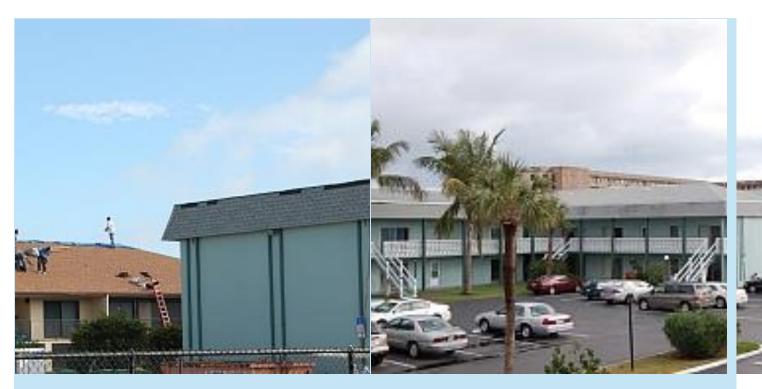
Illustrating the proximity of Diplomat Condo to Windrush Condo. The roof from building in foreground hit the building behind it.

This illustrates how the roof structure of the Diplomat Condo appeared like prior to the tornado. This is a another building in the Diplomat Condo complex.
