Overview of The Central Florida Tornado Outbreak February 22nd & 23rd, 1998

The graphics below depict an approximate track of the thunderstorm "supercells" which produced the mesocyclones associated with the tornadoes that raked Central Florida on the 22nd & 23rd of February, 1998 and killed 42 people. These mesocyclone tracks are approximated from radar imagery. Some of the imagery is provided here for an overview.

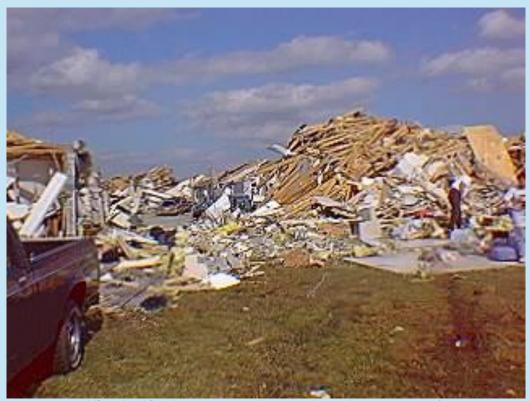
View looking between two homes, through to a street of severe damage (more pictures below)

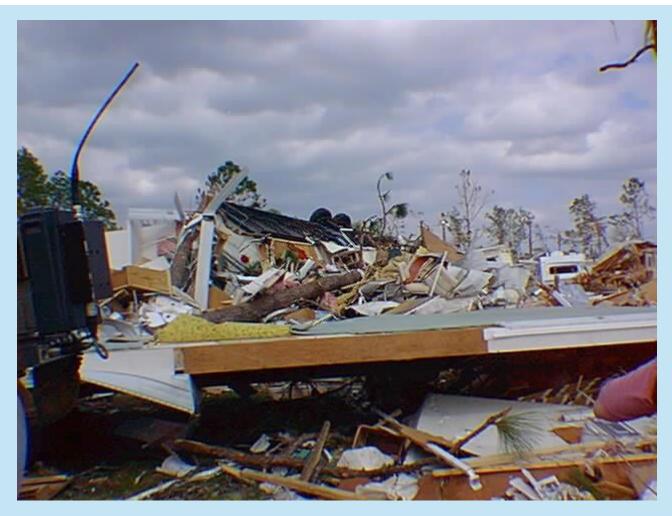
RV Park damage in Kissimmee.

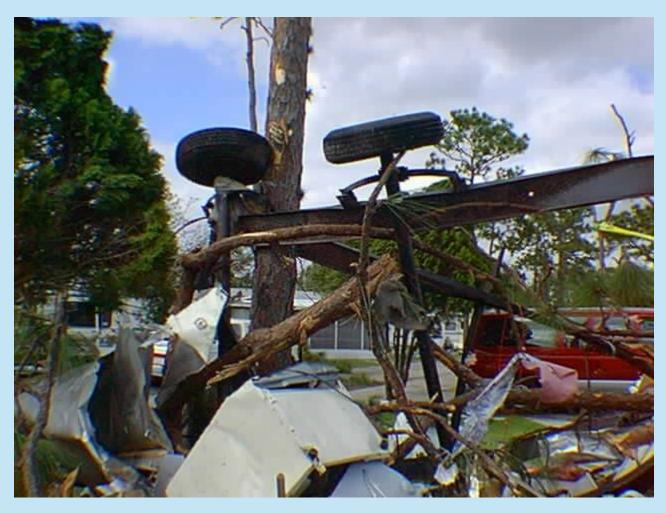
RV frame wrapped around a tree. Note relatively undamaged areas nearby.

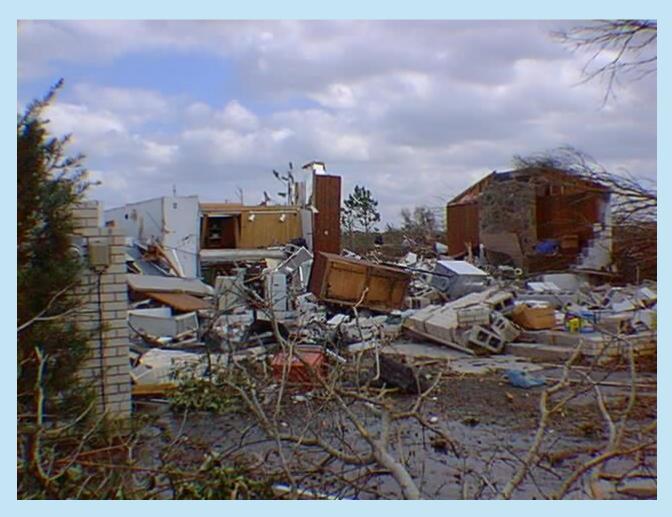
Looking through the garage door of a severely damaged concrete-block and brick veneer building.

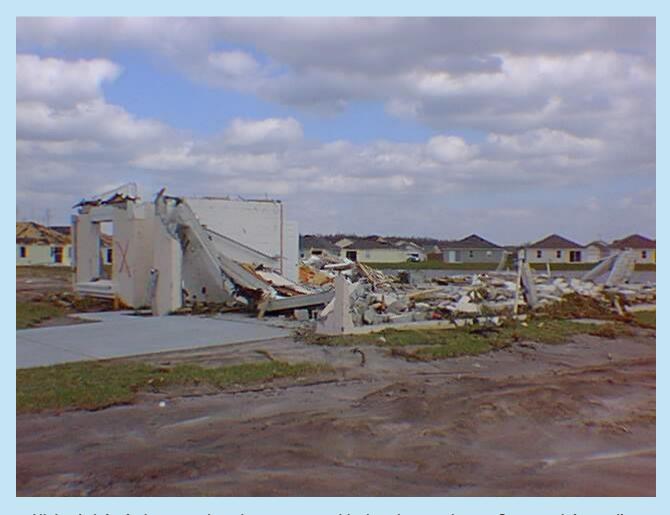
All that is left of what was a brand-new concrete-block and stucco home, Structure left standing is front-door entryway and one partial wall with a window. This subdivision was directly across the Florida Turnpike from the RV Park, where damage photos above were taken.
