Reynolds Channel at Pt Lookout

at 11.2 ft MLLW / 10.1 ft NGVD / 6.6 ft MHHW

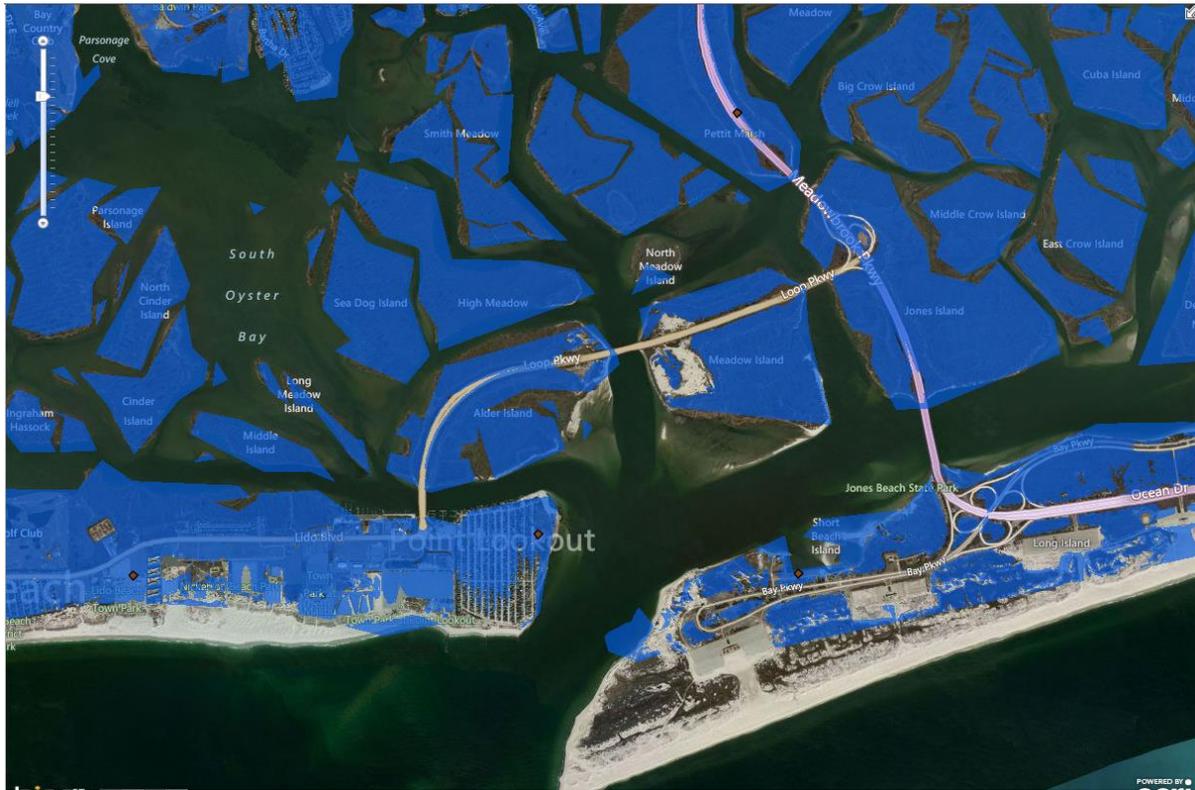
Coastal communities along Southern Nassau experienced four successive tidal cycle with at least moderate coastal flooding. Widespread record coastal flooding occurring along the Western Great South Bay exceeding the FEMA 100 year base flood elevations. Peak storm tides surpassed all previously documented high water marks, including the October 31, 1991 and December 11, 1992 nor'easters and the recorded peaks from Hurricane Irene in 2011. The storm tide levels along the Southern Nassau County shore resulted from a peak storm surge of about 8 to 9 feet that coincided with normal high tides. This resulted in up to 3 to 5 feet of inundation of communities in and along Southern Nassau County.

The majority of locations south of Merrick Road and Atlantic Avenue were completely inundated, with waterfront communities along creeks and streams being inundated up to Sunrise Highway. Areas of major residential damage were experienced across low lying areas such as Inwood, Meadowmere Park, Bay Harbor, Island Park, Baldwin Harbor, Freeport, and Massapequa.

The most widespread major damage was experienced along the barrier beach communities, where the surge was amplified by the run-up and setup from 15 to 20 ft breakers along the Atlantic Ocean coast. Numerous homes and Atlantic Ocean facing structures, such as boardwalks and piers, in Long Beach and Lido Beach were completely destroyed. Jones Beach - Extensive damage and flooding occurred throughout the park, both on the Atlantic Ocean and Great South Bay side. Just over 1/2 mile of boardwalk was damaged or destroyed. Two fishing piers on the Bay side were damaged or destroyed. Jones Beach Theater was completely flooded, including the orchestra section and up to four feet of water in the promenade and concession areas. Field 6 parking field partially collapsed in one section. The floor also buckled in the Central mall concession stand.

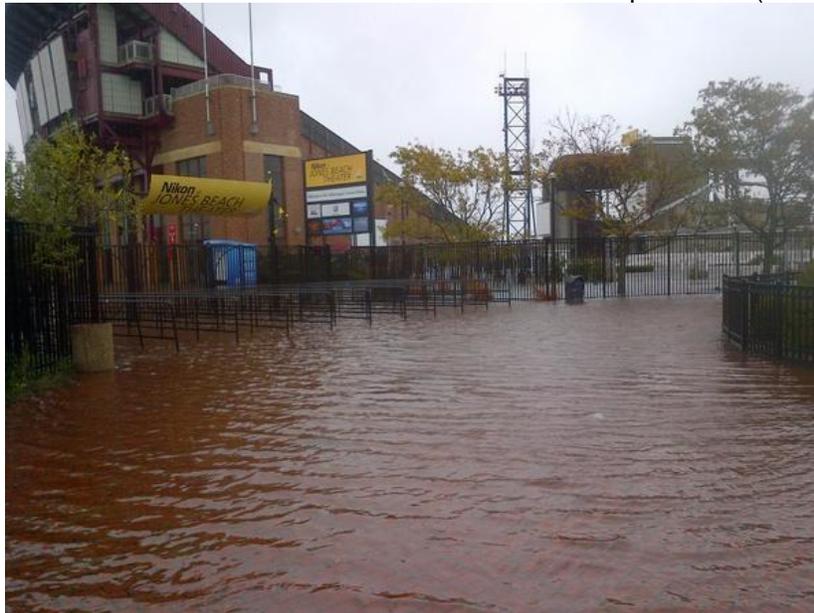
Jones Beach – 1 to 3 feet of inundation in the Jones Beach Amphitheater (10/29/2012 8-10am)

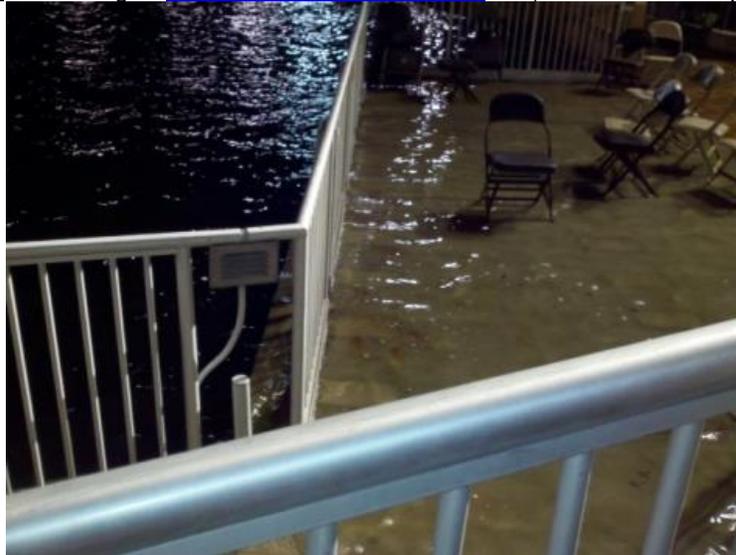
Jones Beach - Flooding at [Jones Beach Amphitheater](#) on (8/12/10 at 1110 pm)

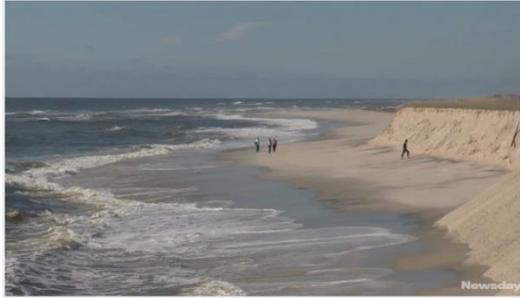
Gilgo Beach - Significant erosion along Ocean Parkway between Jones Beach State Park and Captree State Park. The erosion was within 15 feet of the eastbound roadway along Ocean Parkway at Gilgo Beach, Town of Babylon. This forced closure of some eastbound lanes while emergency repairs were underway. There were other sections along Ocean Parkway also saw significant erosion.

Eastbound Ocean Parkway was closed Monday for emergency roadwork after a storm south of Long Island out over the Atlantic Ocean churned up waves that eroded a chunk of a newly rebuilt dune in Gilgo Beach. Videojournalist: Jim Staubtser (October 14, 2013)
